PROGRESS REPORT ON
DRAINAGE INVESTIGATIONS

EMMETT VALLEY
GEM COUNTY, IDAHO

George B. Bradshaw
Drainage Engineer

Boise, Idaho
June, 1953

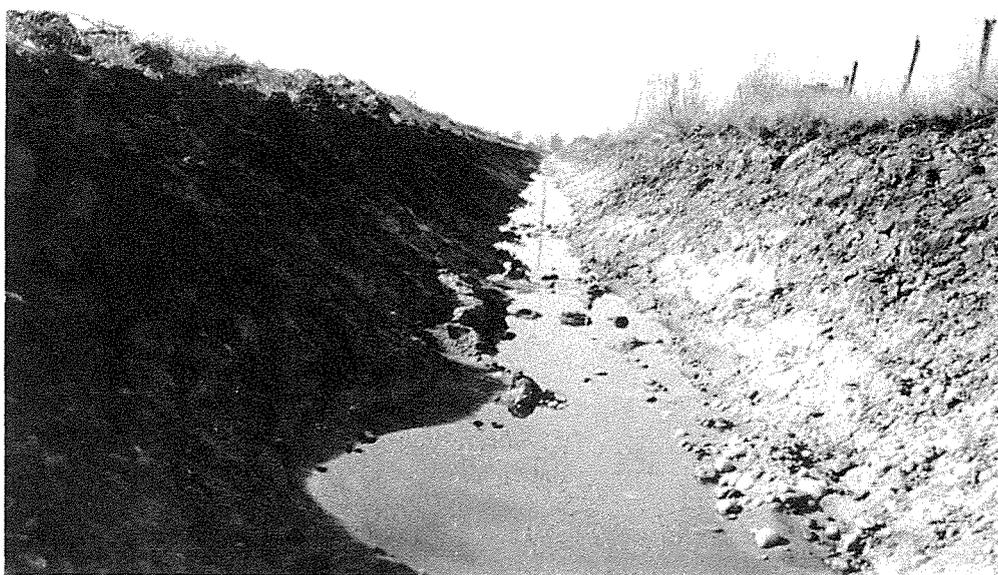
Figure 10. Looking west along open drain, from the north east corner of the farm. Drainable strata of sand and gravel is visible below a two foot soil cap.

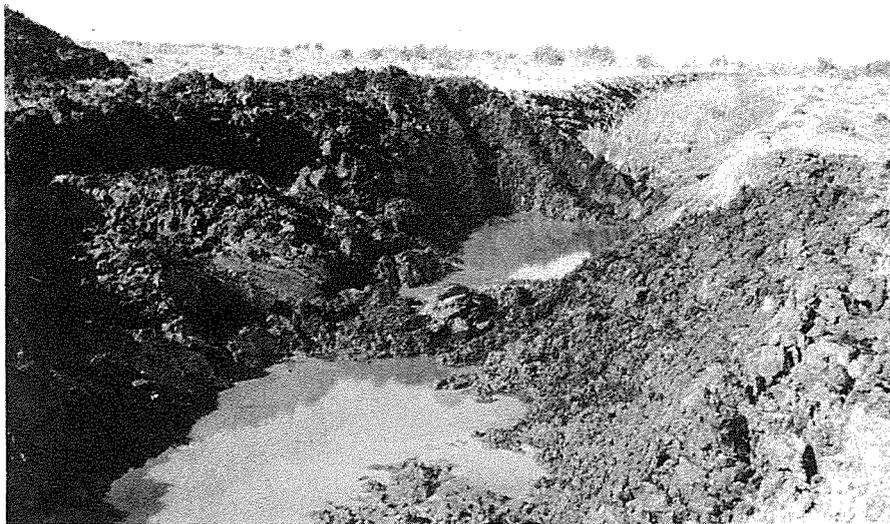
Figure 14. Looking north along partially constructed drain. Caving and sloughing tendency of drain bank is shown.

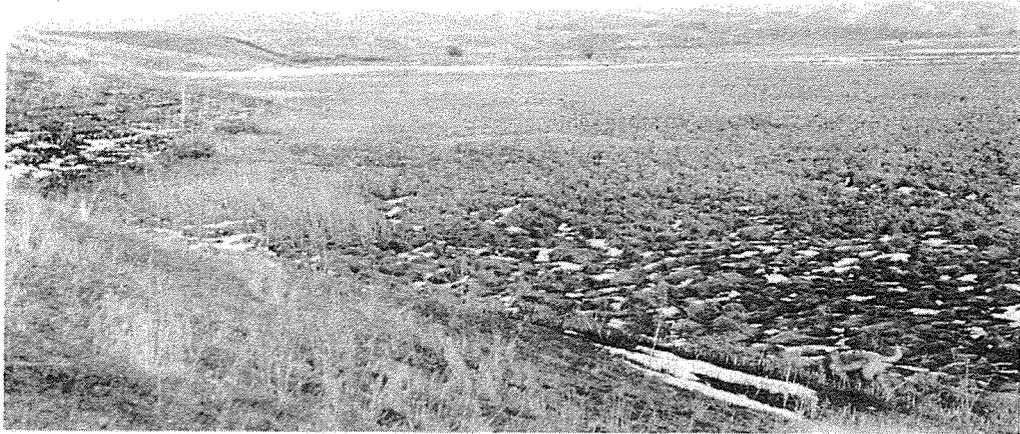
Figure 17. Looking north along proposed route of interceptor drain. The soils belong to the Snow series and are primarily clay loam.

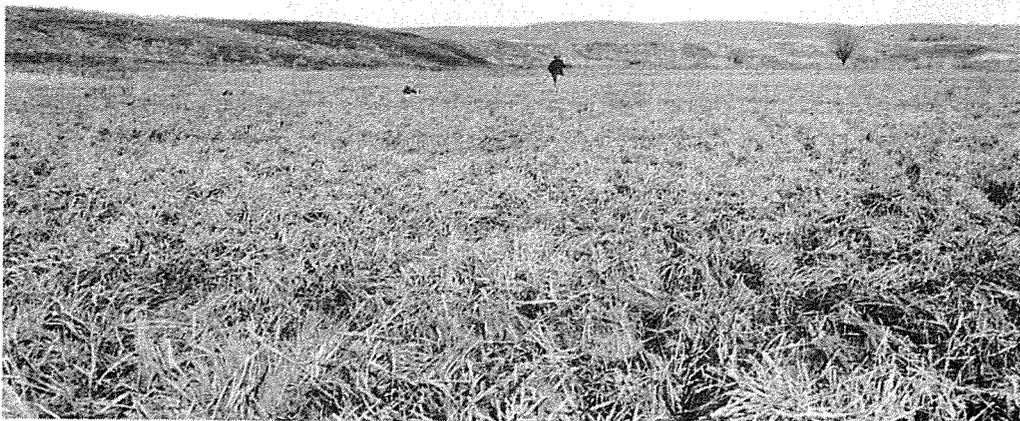
Figure 18. Looking north west over the bog section. During the summer months seepage water accumulates and stands 2 or 3 inches deep on the surface.

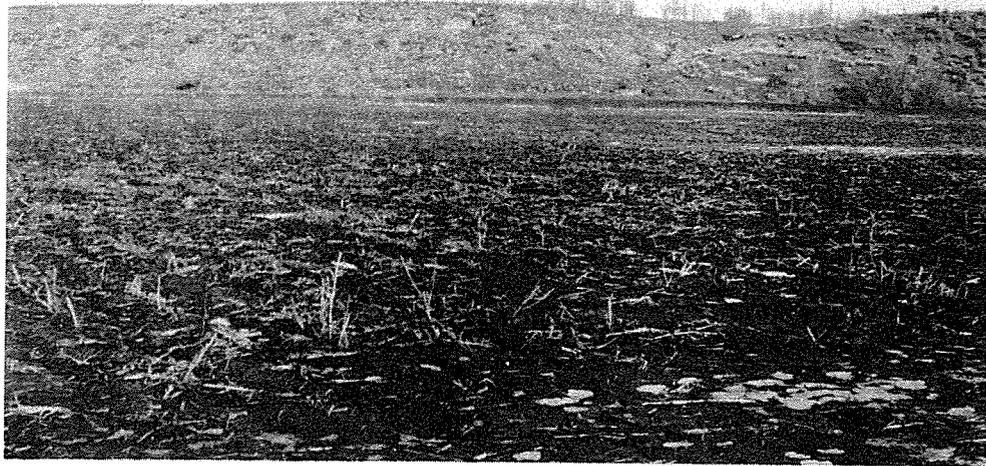
Figure 21. Looking north towards the Emmett Bench escarpment. The soils belong to the Snow series and are primarily loam and clay loam.

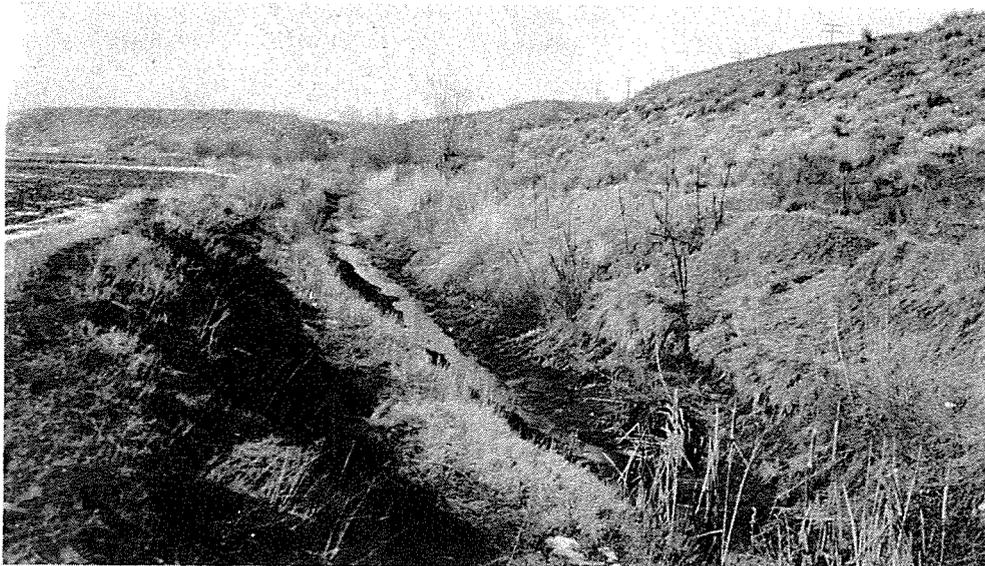
Figure 22. Looking west along the interception drain. The drain is located at the break in grade and soil change to intercept seepage water from the bench.

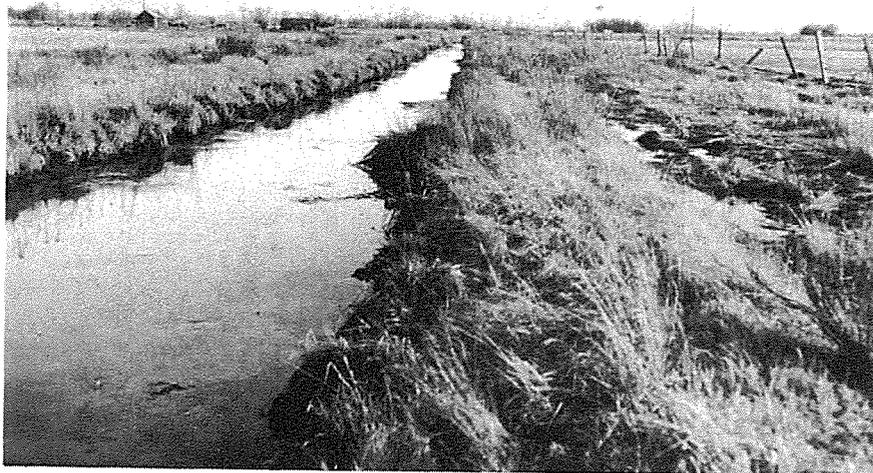
Figure 26. Looking east along shallow ditch at the north side of the farm. The ditch is 1 1/2 feet deep and approximately 12 feet wide.

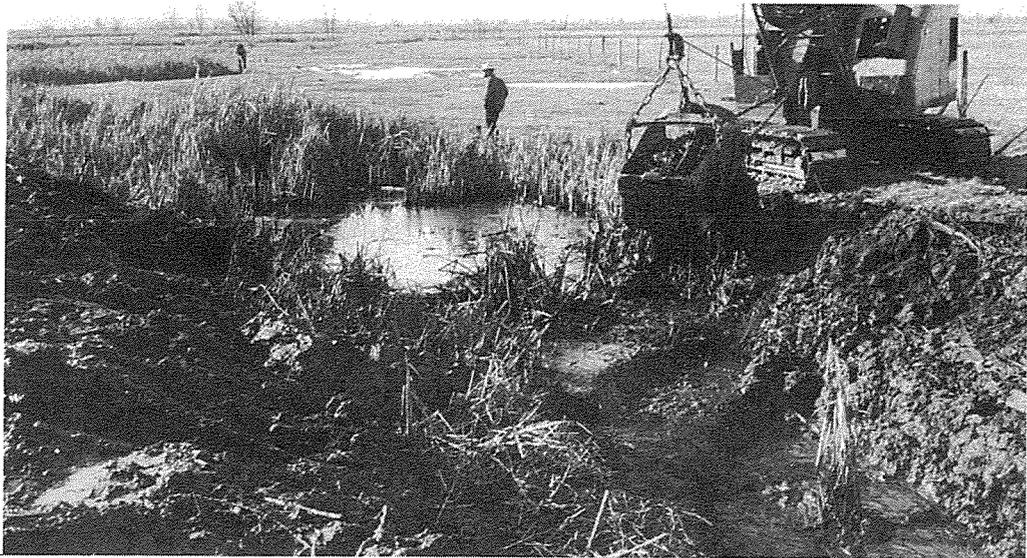
Figure 30. Looking west from south center of farm. Slough is being cleaned and deepened and will be used as an interceptor drain.

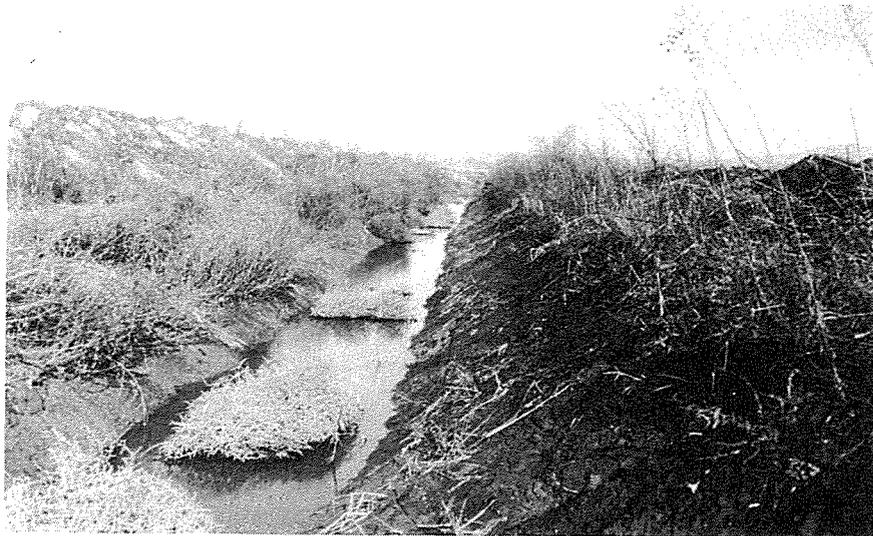
Figure 34. Looking north along section of drain that was installed during 1952. This section of drain is in slowly permeable soil.

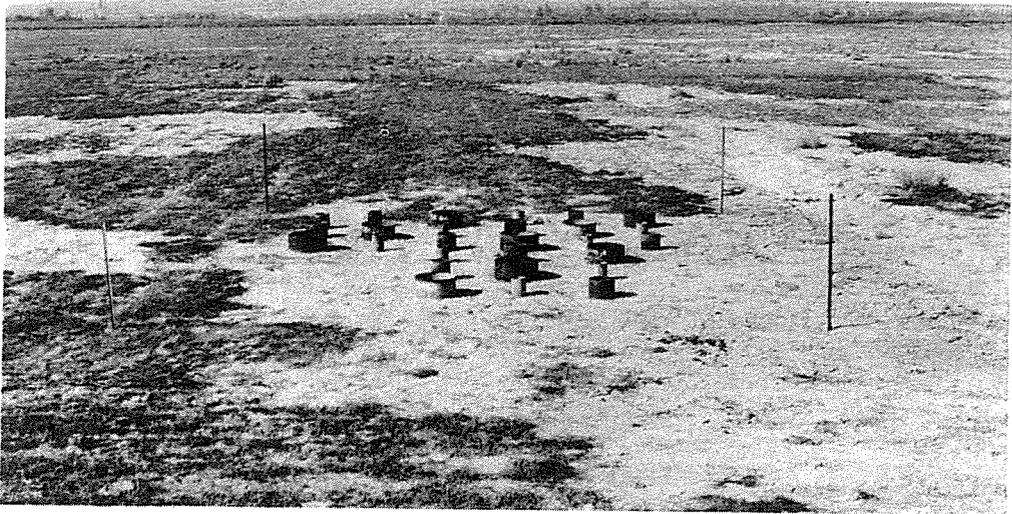
Figure 37. Looking north over the Ranch "I" alkali reclamation plot. The soils are silty clay to 10 feet and strongly alkaline in the top two feet.
