2006 Irrigated Land Classification for the Eastern Snake Plain Aquifer

Introduction

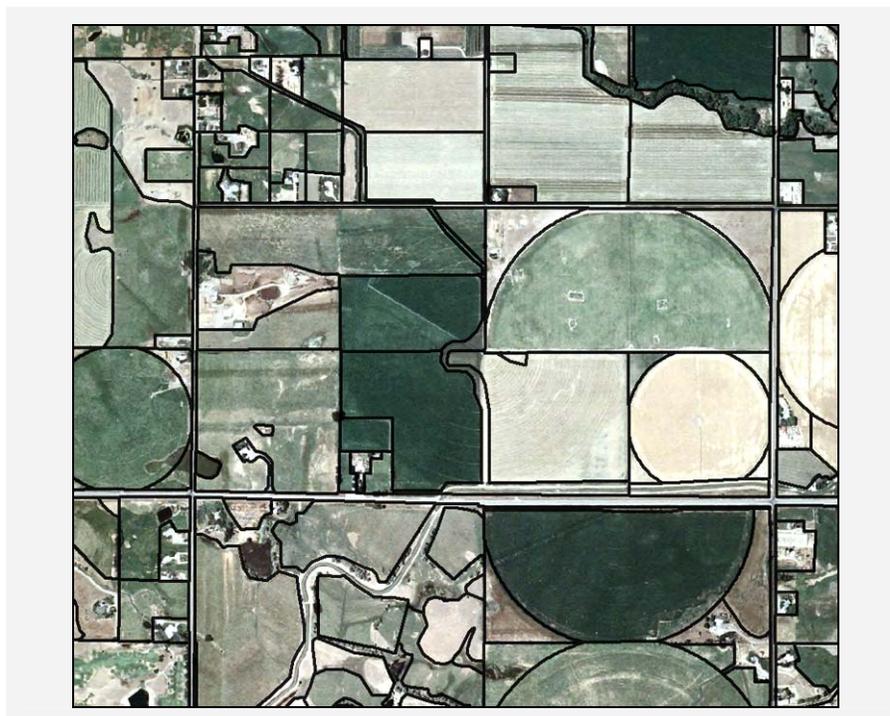
Figure 2. Common Land Unit (CLU) polygons in black superimposed on a National Agricultural Inventory Program (NAIP) image.

In conjunction with the image data, IDWR analysts used Common Land Unit (CLU) polygons of individual fields that were digitized from a combination of 2004 and 2006 NAIP imagery by the Farm Services Administration (FSA). Although FSA will allow access to CLU polygons, they deny all requests for access to the associated attribute data, including the land-cover codes. IDWR, therefore, used the unattributed CLU polygons. The CLU polygons were used because they are an existing, recent, highly-detailed, vector dataset that IDWR could attribute easily as irrigated or non-irrigated. Figure 2 shows CLU polygons superimposed on a NAIP image.

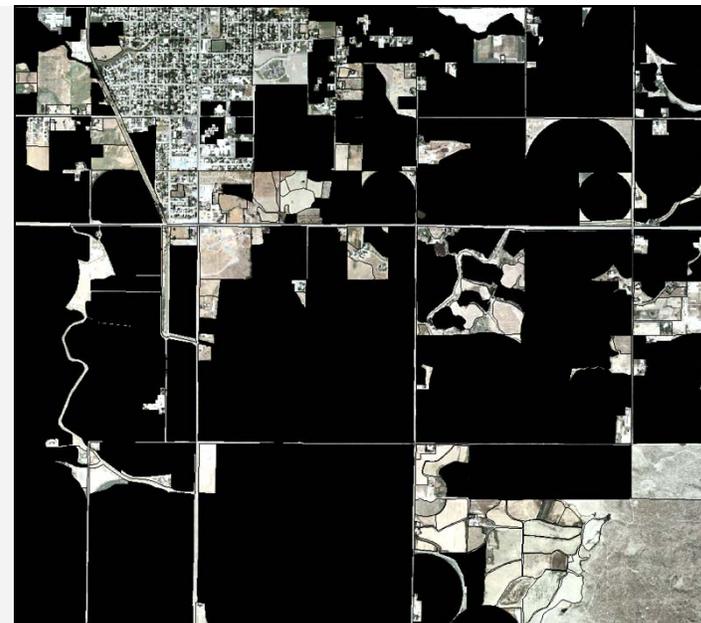
Figure 6. Irrigated polygons masked to black and superimposed on 2006 NAIP image data.

The third step was to review the initial Irrigated/Non-irrigated classification by superimposing the classified image on top of the 2006 NAIP digital photography. This was done by alternately masking irrigated polygons (Figure 6), then by masking non-irrigated polygons (Figure 7), and finally by overlaying the masked image sequentially on all available dates of Landsat data, as illustrated by Figure 8, one date at a time, and on the NAIP images. IDWR used several dates of raw Landsat data that were not available as NDVI images.

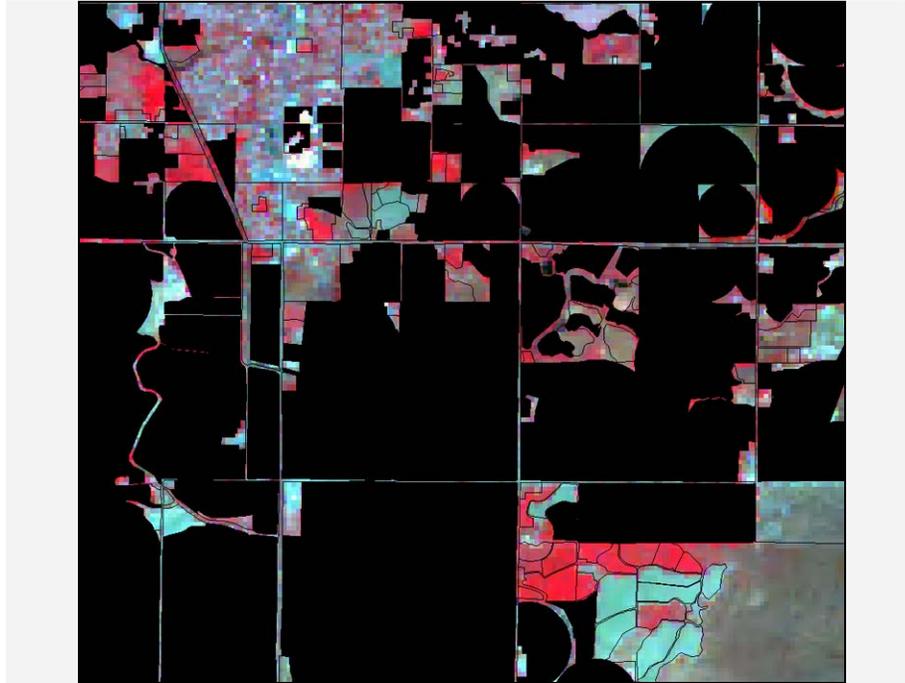
Figure 7. Irrigated polygons masked to black and superimposed on Landsat data from May 19, 2006.

Figure 7 shows masked irrigated polygons on a Landsat image. What is not masked is classified as non-irrigated. There are some irrigated fields (bright red in the color infrared image) being classified as non-irrigated. Those misclassifications were corrected by simple re-assigning as irrigated each CLU that showed up red. The process was repeated for available each date of Landsat data, and for the NAIP. This process caught land that was irrigated early or late in the season, periods that were not covered by the initial 3 dates of NDVI images or the NAIP.

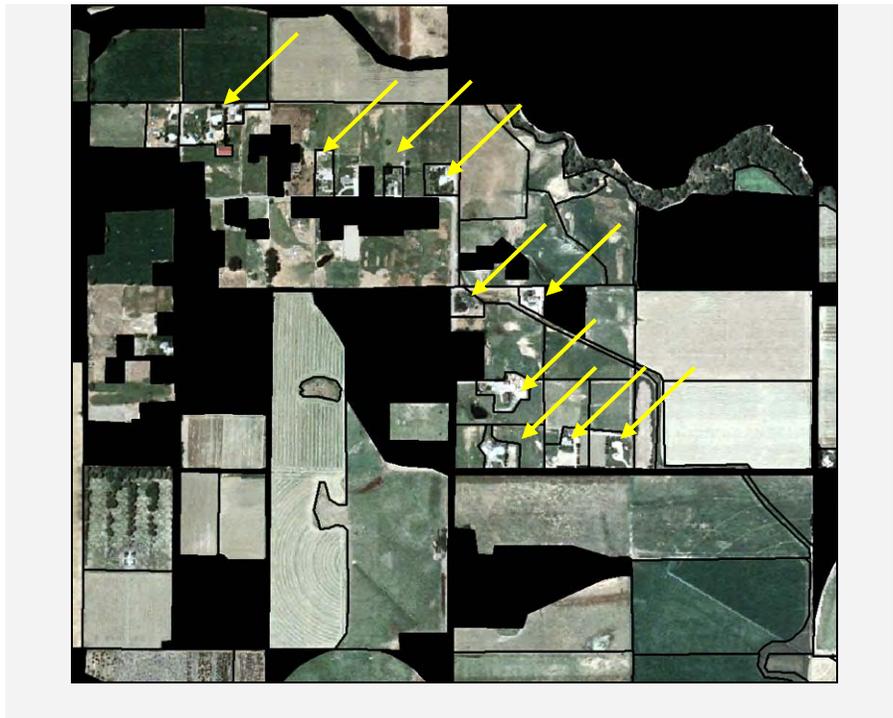
Figure 9. Non-Irrigated mask on NAIP. Arrows point to some residential land classified as irrigated. Those polygons are changed during editing.

The entire classification could have been done using just Step 3, but it would have taken longer and been more tedious. The first two steps were designed to classify quickly those fields that the computer could readily identify as irrigated. The third step was designed to use a human interpreter to make subtle decisions that were beyond the capabilities of the software, and to correct any classification errors. Figure 9 shows an example of one kind of those errors. Steps 1 and 2 resulted in small polygons of residential land being classified as irrigated. In Step3, those polygons were changed from “irrigated” to a third class not used in the first 2 steps: “residential.”

The residential class was added because there is generally irrigation occurring in residential areas, but the irrigation is not as intense or wide-spread as is the irrigation on agricultural land. The residential class captures that less-intense irrigation, allowing the hydrologic modelers to assign to that class an intermediate recharge value.
