BLAIR @ Muldoon Ranch 280-1079

ABC ditch

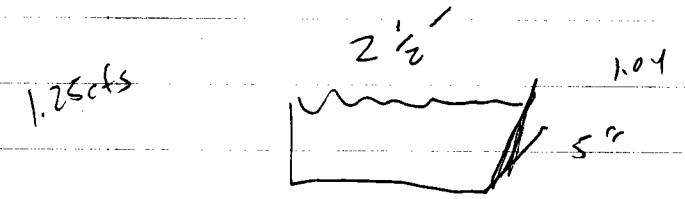
Clark

distance
6 ft

time
5 seconds
