Hagerman Valley Geology

The Effect of Large-scale Heterogeneities and Geologic Structures on Spring Spatial Distribution

By: Neal Farmer

Idaho Department of Water Resources

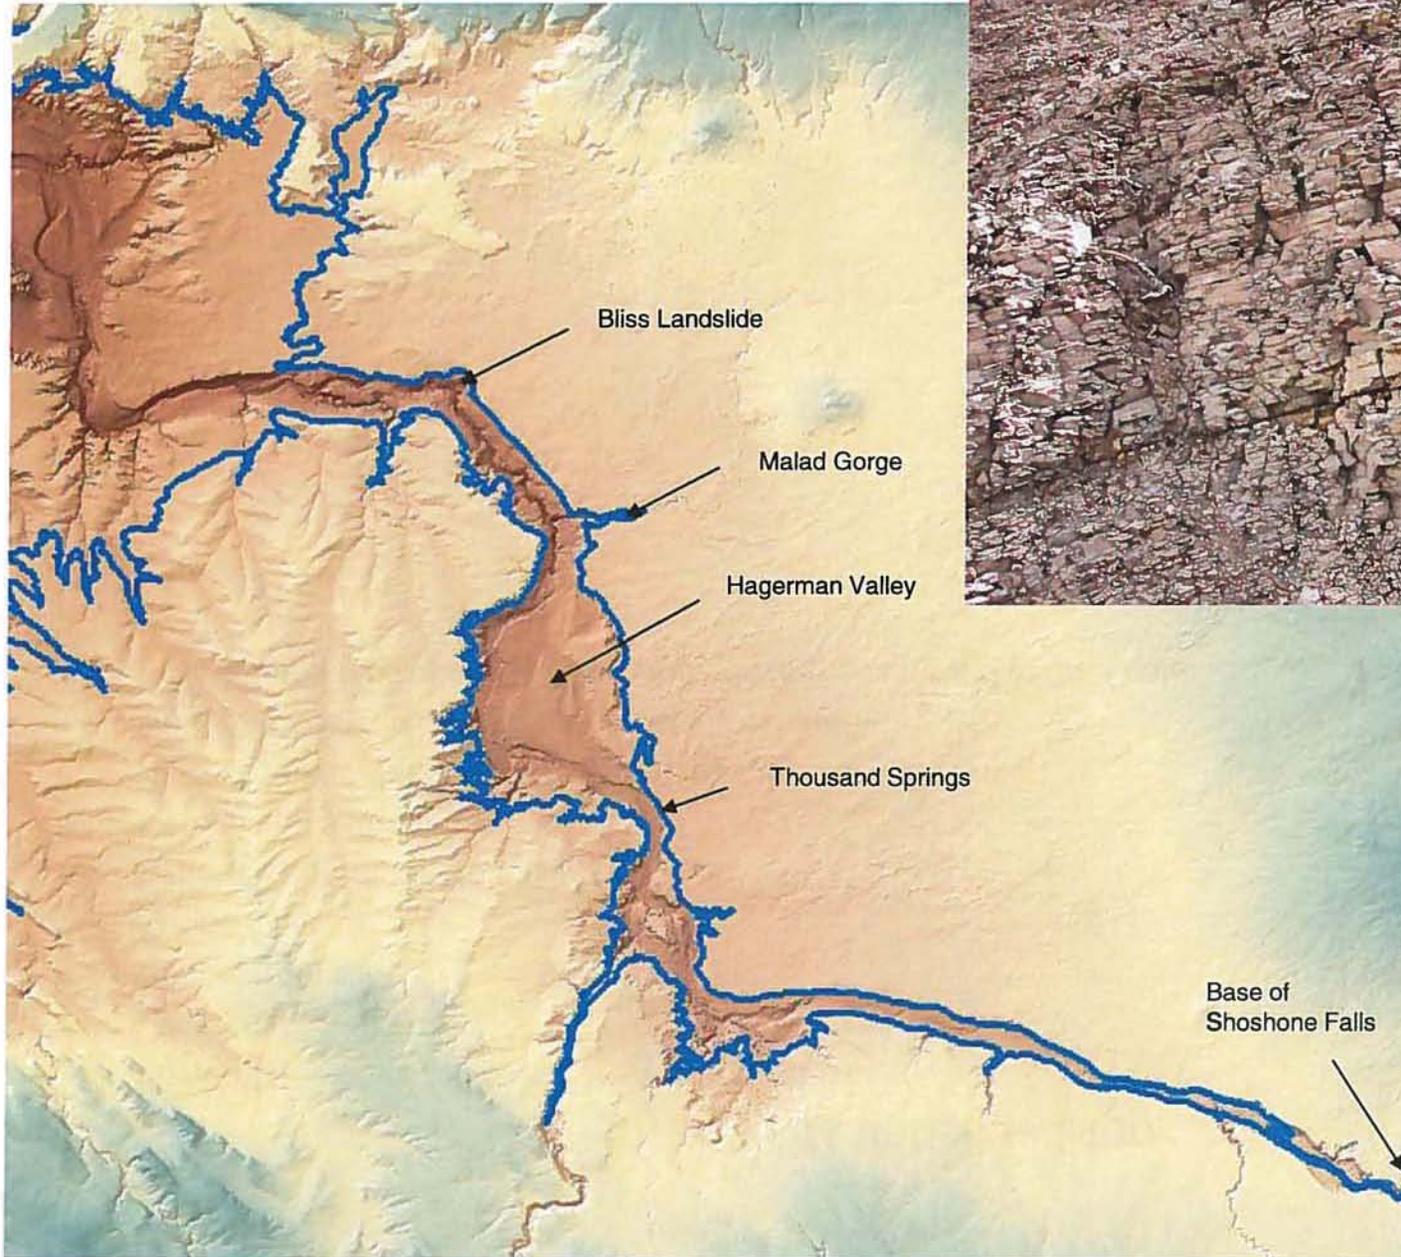
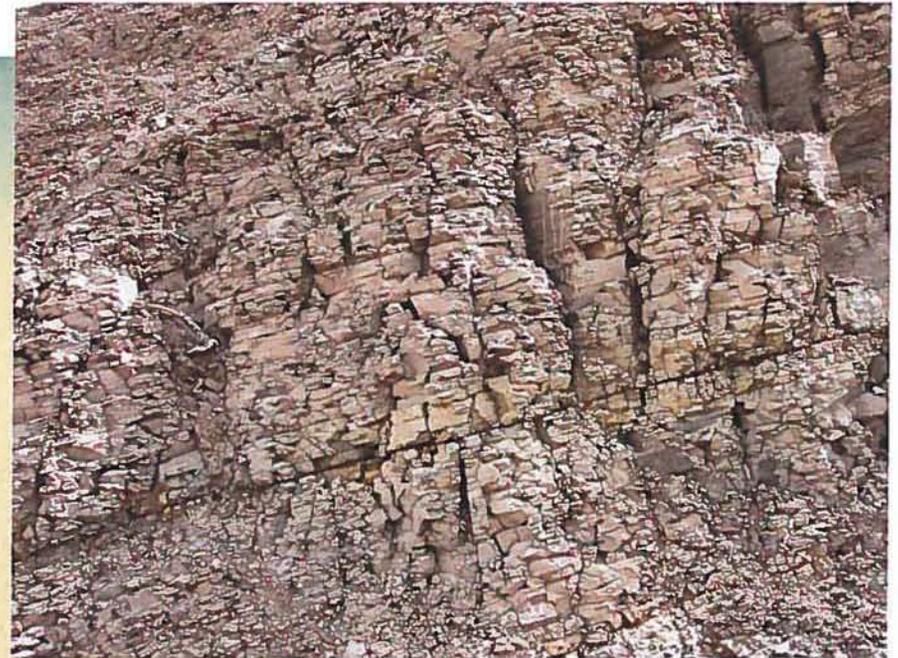
“Lake Yahoo”

McKinney Butte erupted about 50,000 y.b.p. and discharged a basalt flow into the Snake River Canyon blocking and damming the river which deposited the Yahoo Clay Formation (Malde, 1972) . The lake would have nearly filled the Hagerman Valley from rim-to-rim and extended from Bliss area upstream to possibly the base of Shoshone Falls.

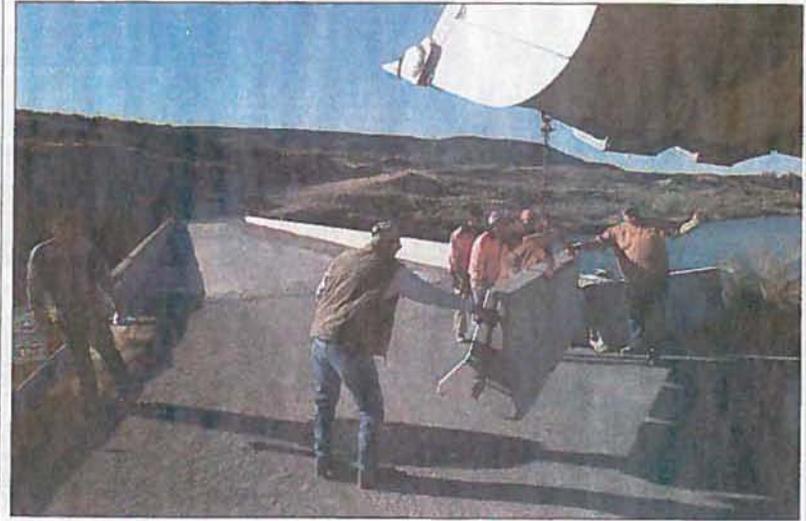
Photo by GUY WITTE/The Times-News
An Idaho Transportation Department crew barricades off the Bliss bridge early Saturday morning. The bridge was declared unsafe for vehicular traffic after two underwater inspections determined that the high velocity of the Snake River and the unstable foundation of the bridge could result in bridge failures.

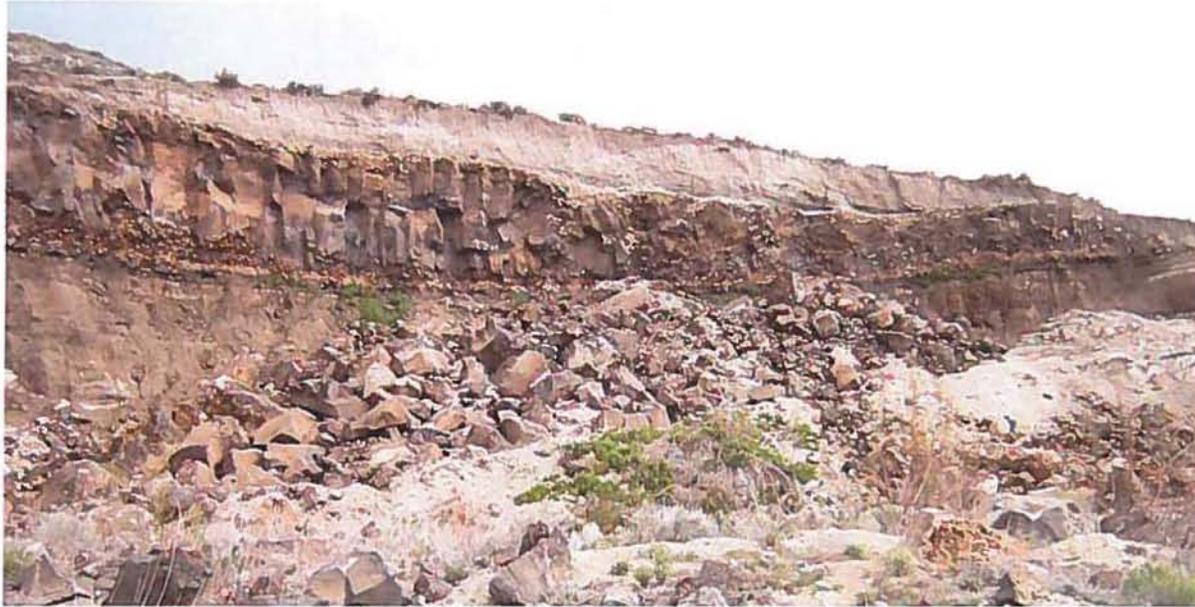
Intercalated Tertiary age basalt within the clay rich sediments of the GFF dated at 3.4 million years old (Hart, 1999).

Discharge from the rubble base of this basalt flow, at only this location of the headwall scarp of the 1991 landslide, averages 200 gpm or 2,900 ac-ft per year. Tracer tests record groundwater flow velocities ranging from 150 to 200 linear feet per day.

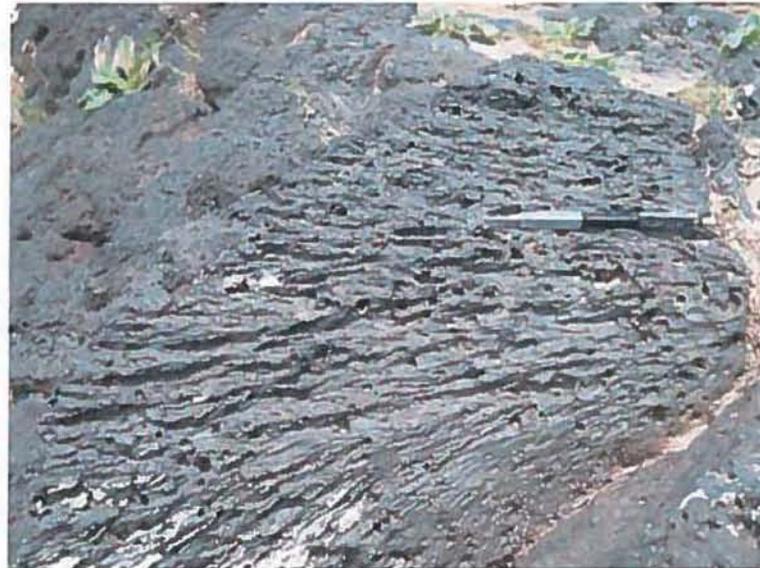
Scoured Scabland Basalt from the Bonneville Flood c.a. 15,000 y.b.p.

- Note scoured flute surface features on basalt and how they trace the paleo flow patterns.

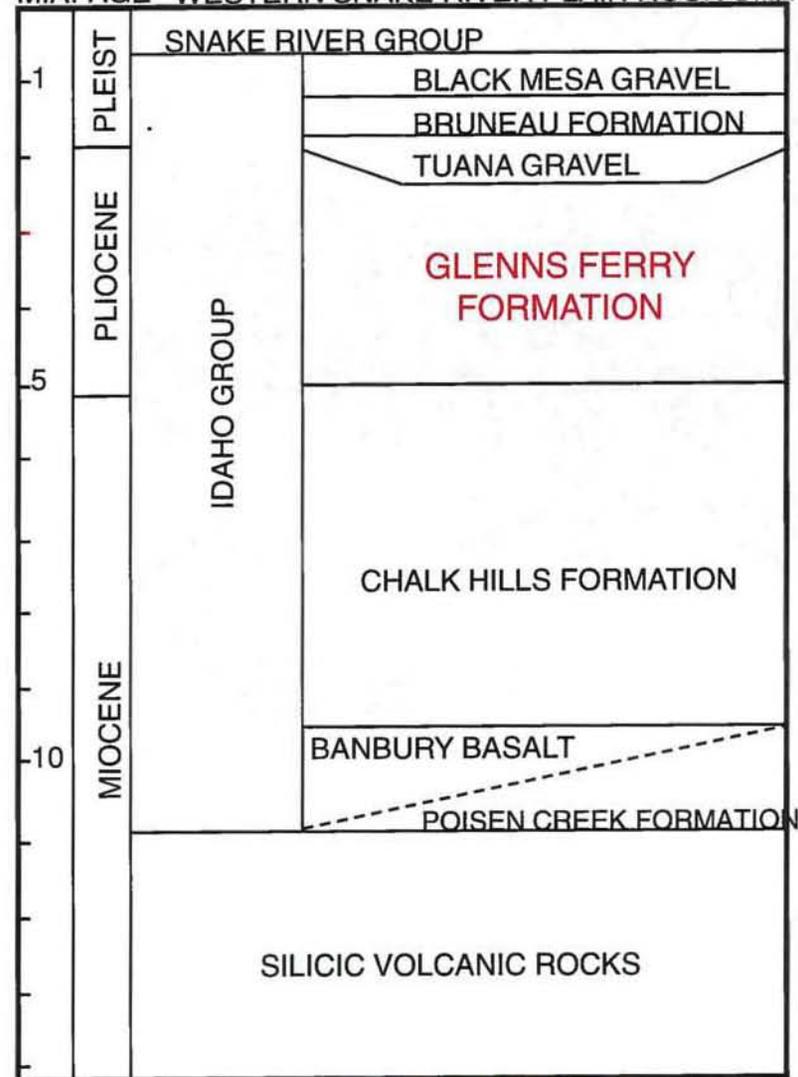
M.A. AGE WESTERN SNAKE RIVER PLAIN ROCK UNITS

(modified from Malde, 1972)

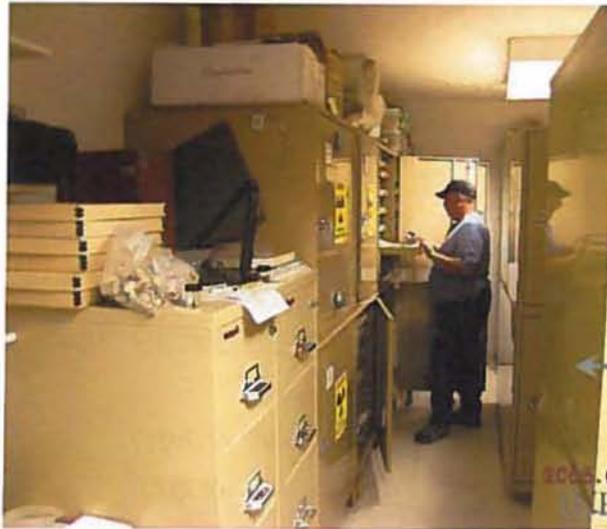
Radon

Cabinet
1996 Test
 Ave. =
436 pCi/L

Max =
544 pCi/L

Data in pCi/l
 Time Interval 4 Hrs

Overall Avg. = 436
 Last 12 Hrs. = 462

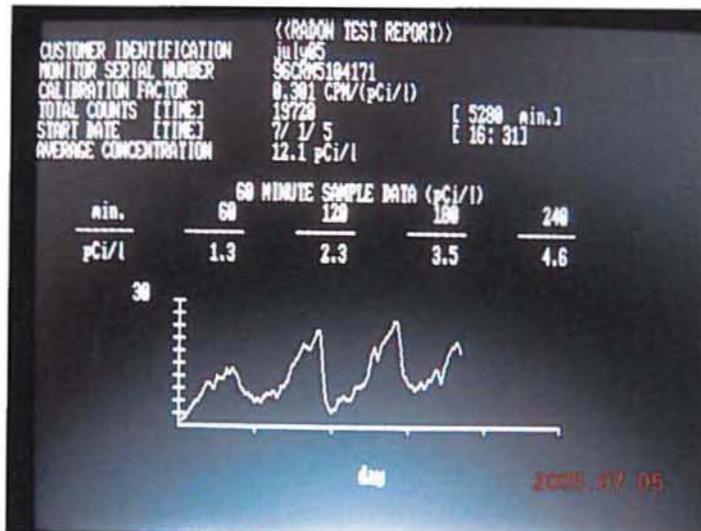
Room
2005 Test
 Ave. =
12 pCi/L

Max =
26 pCi/L

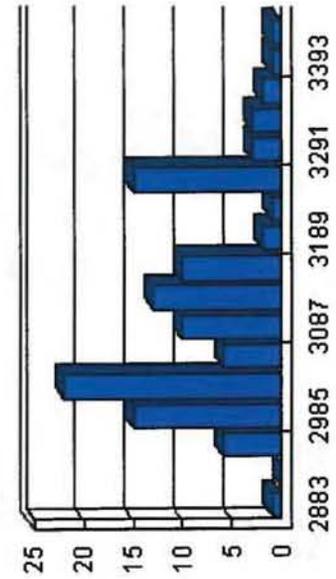
Frequency Distribution

Count:	111
Minimum:	2883.000000
Maximum:	3443.000000
Sum:	346774.000000
Mean:	3124.090090
Standard Deviation:	118.804446

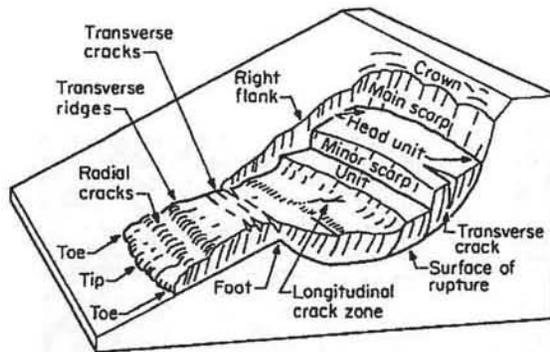
FIG. 9.21 Characteristics and nomenclature of a rotational slide. [From Varnes (1958).¹ Reprinted with permission of the Transportation Research Board.]

A common form of sliding in soil formations is the rotation about some axis of one or more blocks bounded by a more or less cylindrical failure surface. The characteristics at total failure and descriptive nomenclature are given on Fig. 9.21.

During early failure stages tension cracks begin to form as shown on Figs. 9.22 and 9.23. After partial failure, in a progressive mode, the slope exists as a series of small slumps and scarps with a toe bulge as shown on Fig. 9.24, or it may rest with a single large scarp and a toe bulge as illustrated on Fig. 9.25. After total failure, surface features include various head scarps, concentric and deep tension cracks (Fig. 9.26), and a large mass of incoherent material at the toe (Fig. 9.27). (See also Fig. 9.21.)

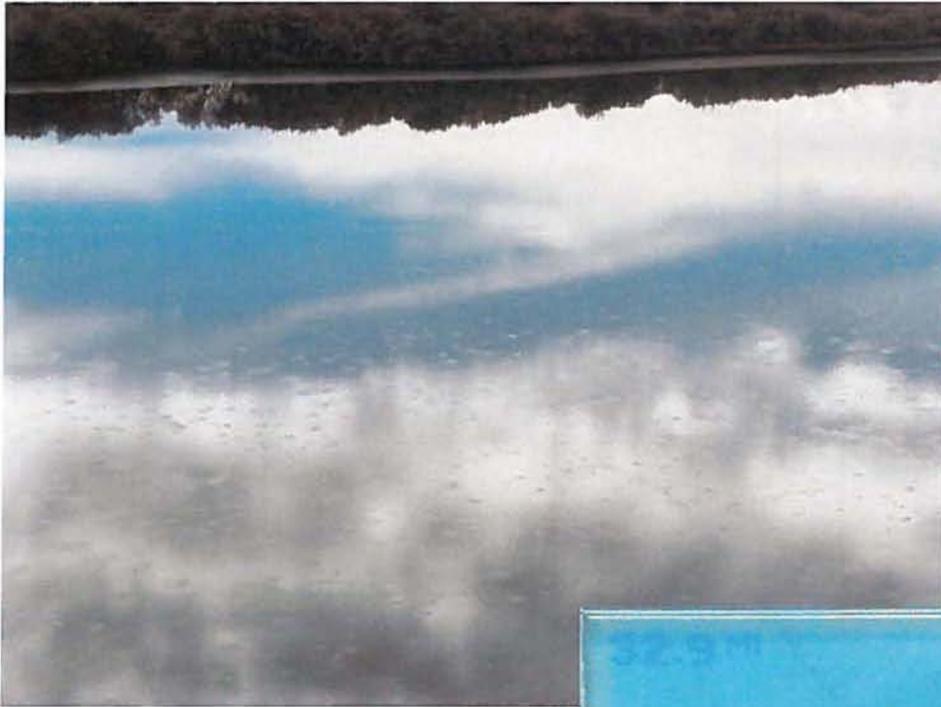
Lower Salmon Falls Reservoir Sediments

Sediments de-gassing during a reservoir drawdown event.

Depth of sediments is interpreted to be about 7 feet over approximately 50 year period or about 1.5 inches per year. So, if the rate continues, in 50 years the shallow flats will be at normal reservoir pool level.

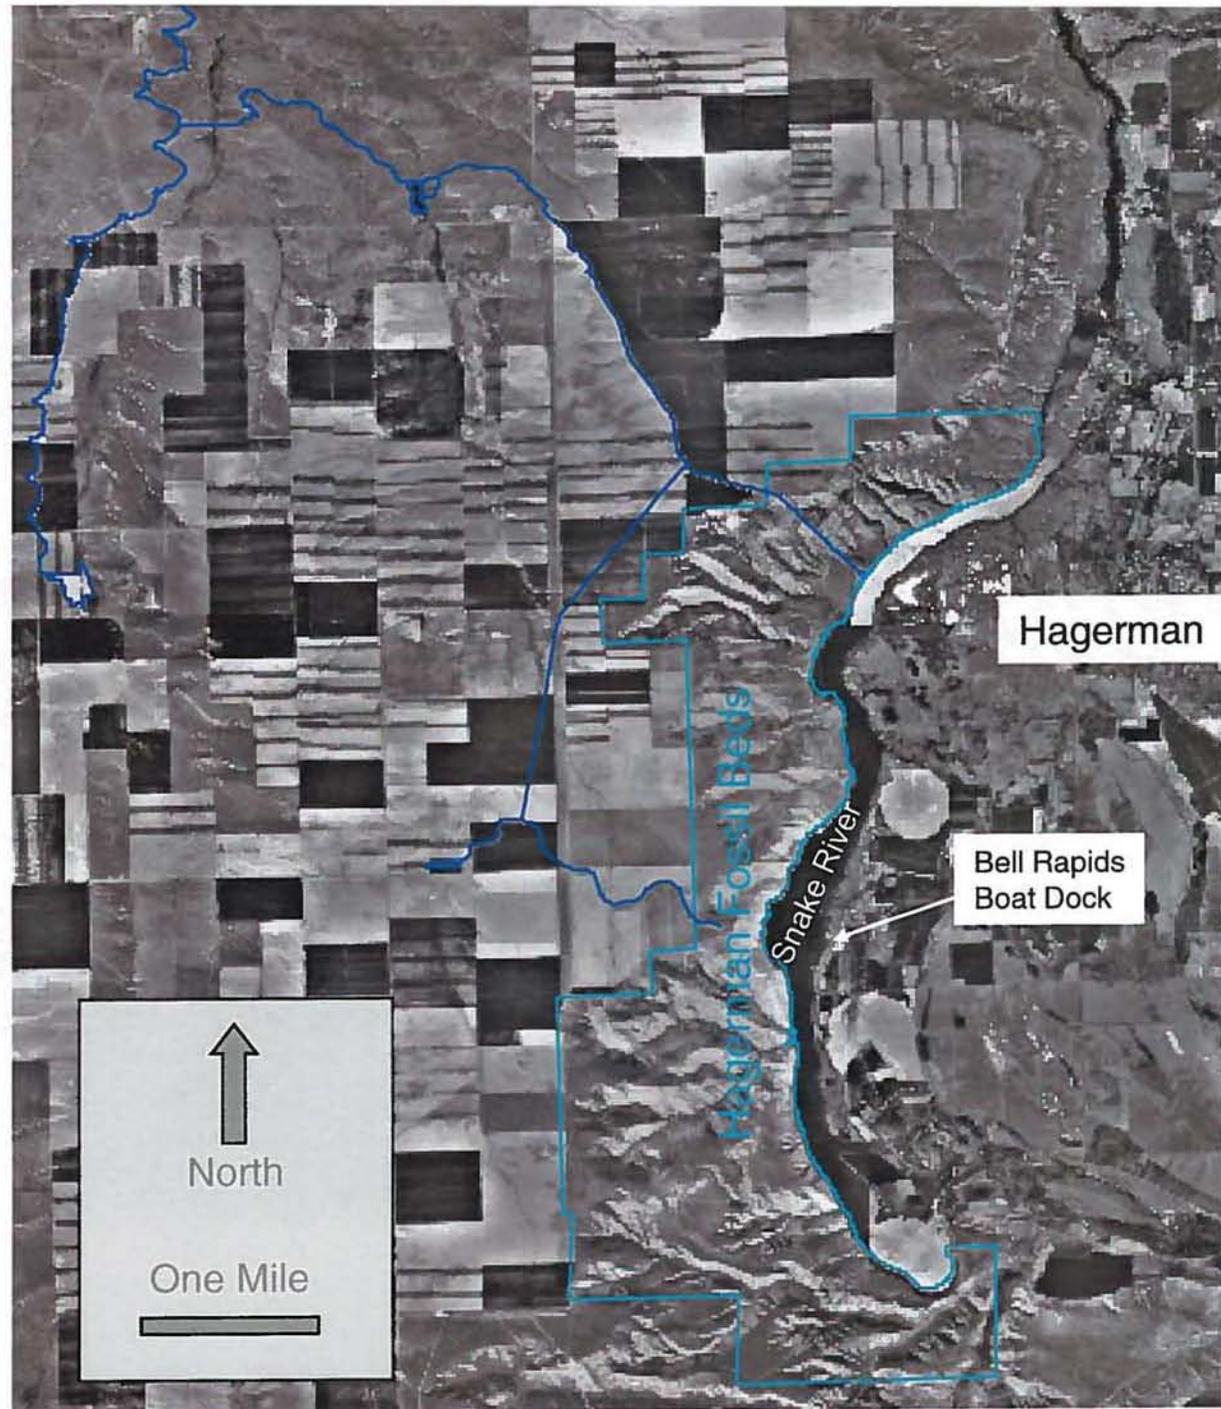
Bell Rapids Project

- 1st irrigation season in 1970
- Last irrigation season in 2004
- 1st landslide associated with perched aquifers in ~ 1979
- originally ~ 25,000 acres
- Ave. annual water usage ~45,000 ac-ft.
- pressurized irrigation only
- 300 miles of pipeline
- originally 2 pump stations on river
- 1987 landslide destroyed one station
- canal leakage tests range from 10 to 20 percent.
- Project shutdown in year 2005

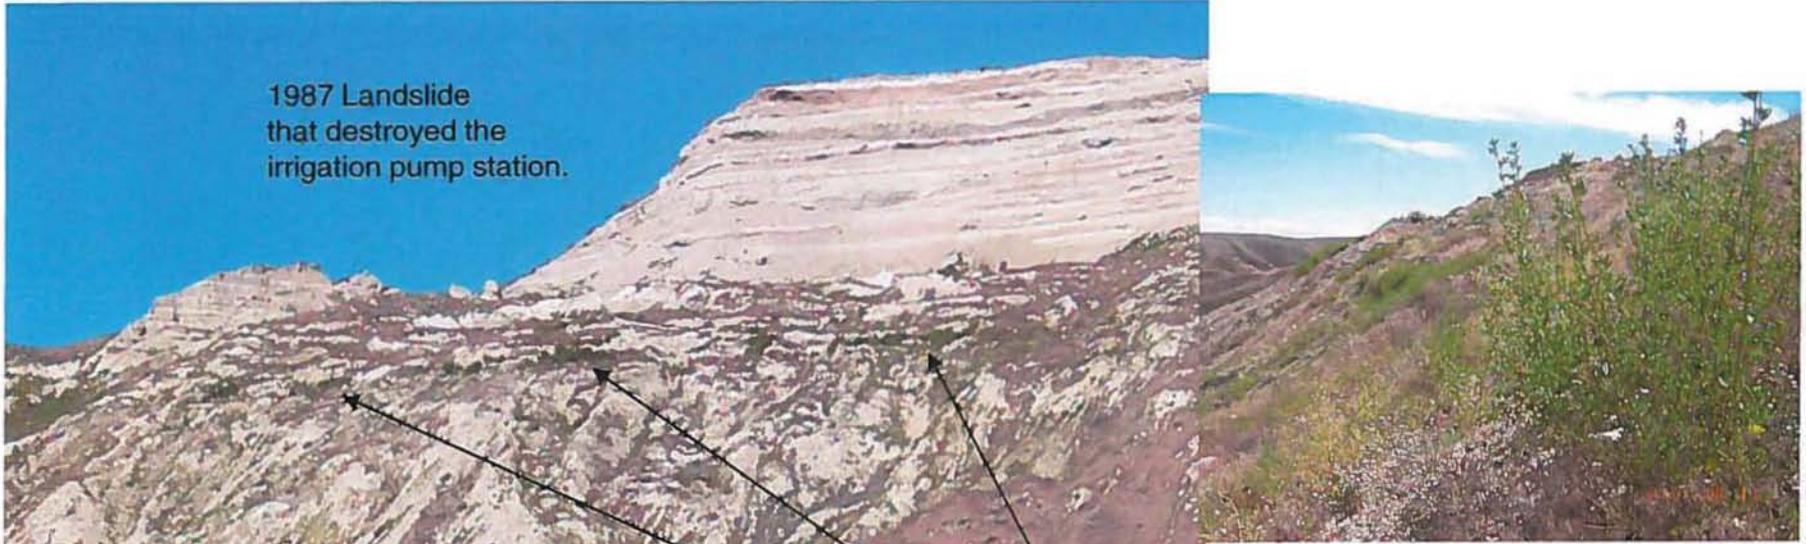
1987 Landslide that destroyed the irrigation pump station.

Line of vegetation may be delineating the contact between the slide overburden and non-disturbed stratigraphy at the lower rotational failure plane underlying the landslide debris. The non-disturbed strata is acting like an aquitard for the recent large amounts of natural precipitation.

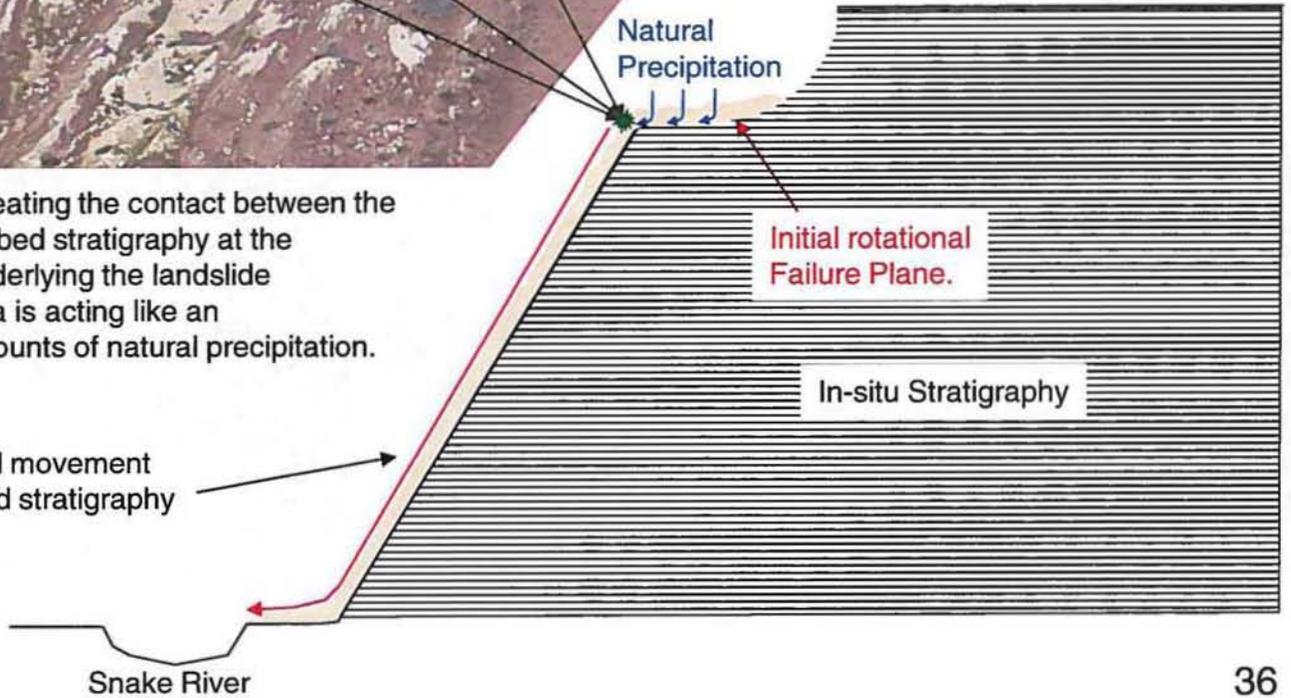
Secondary translational movement of slide with undisturbed stratigraphy underneath.

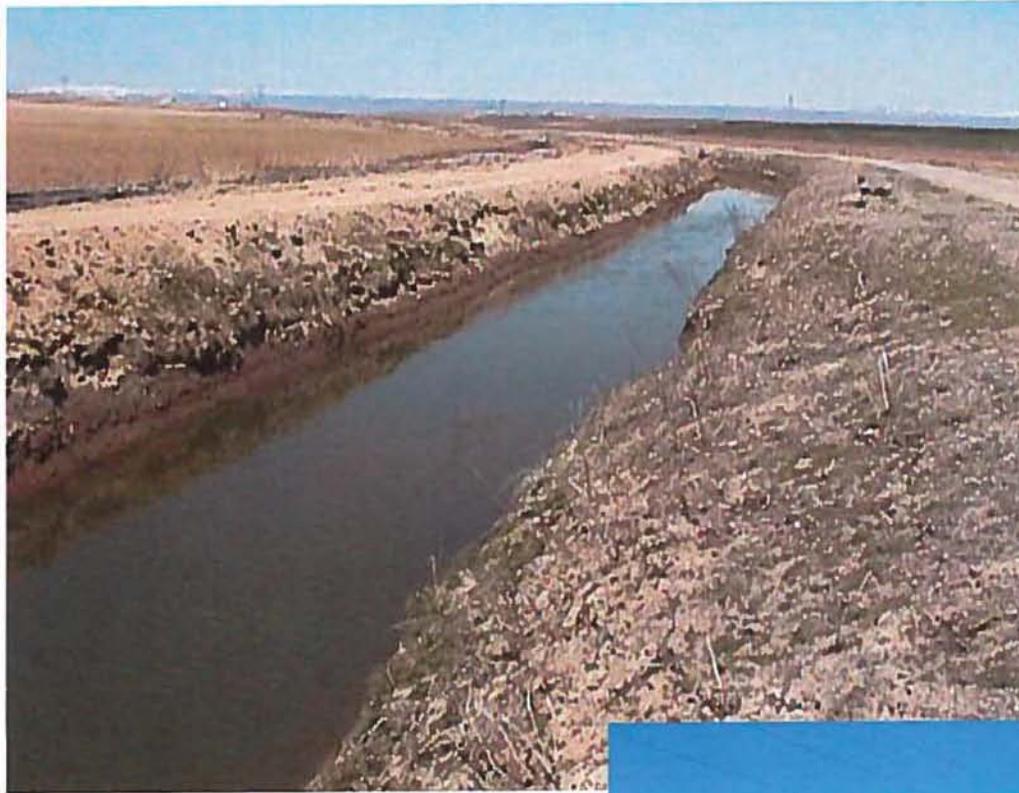
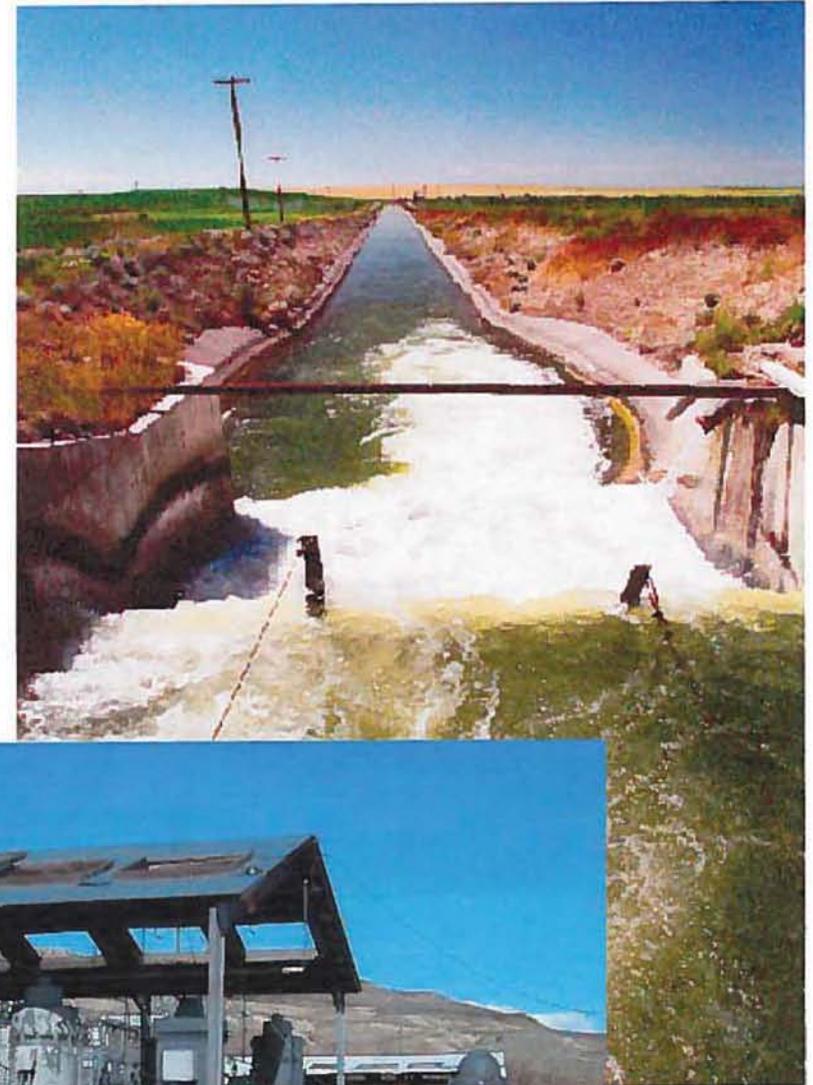
Fossil Gulch Pumping Station and Canal

- Maximum delivery rate exceeded 120,000 g.p.m.
- Each pump = 9,000 g.p.m.
- Each electric motor = 10,000 h.p.
- 3 pipelines up hillside to plateau
- In July 2004 electric costs was ~ \$180,000

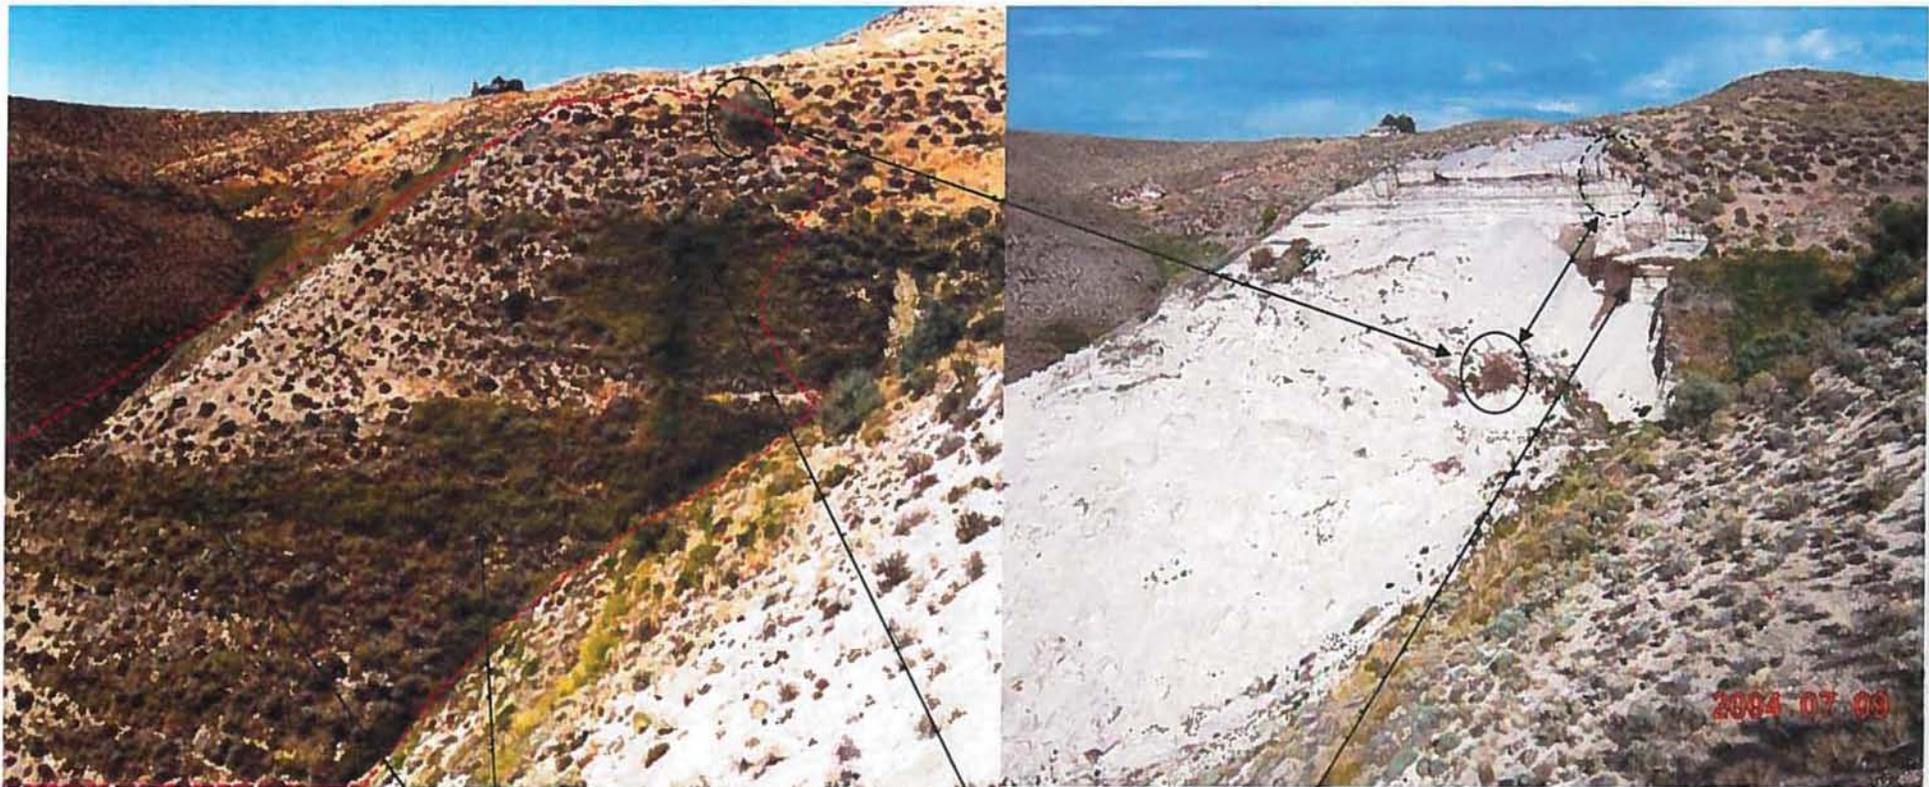
Photo year 1995

Apparent Initial slip surface or shear zone.

Paleo stream sand channel discharging groundwater.

Area of 2004 Landslide

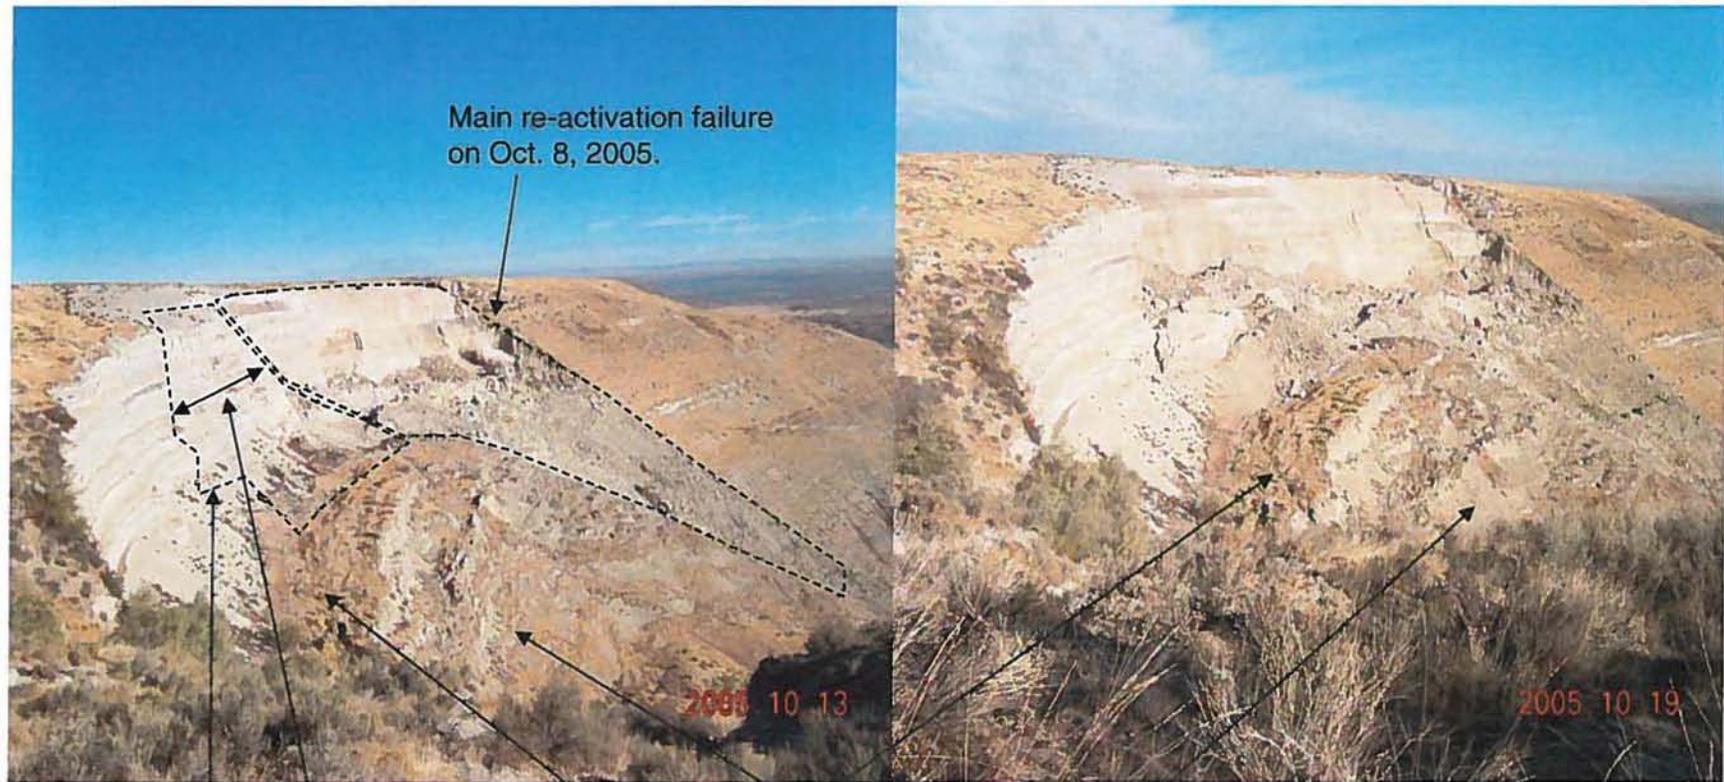
1989 landslide Reactivation

Area that failed between October 13 and October 19, 2005.

Fracture in Oct. 19th photo but not on 13th.

Fresh scarp of Oct. 19th photo but not in Oct. 13th.

Distance is about 25 – 30 meters.

1989 landslide sat dormant for 16 years then reactivated with a headwall scarp failure in year 2005. The failure started on the north edge and progressively failed in sections across the headwall scarp right to left (south) edge.

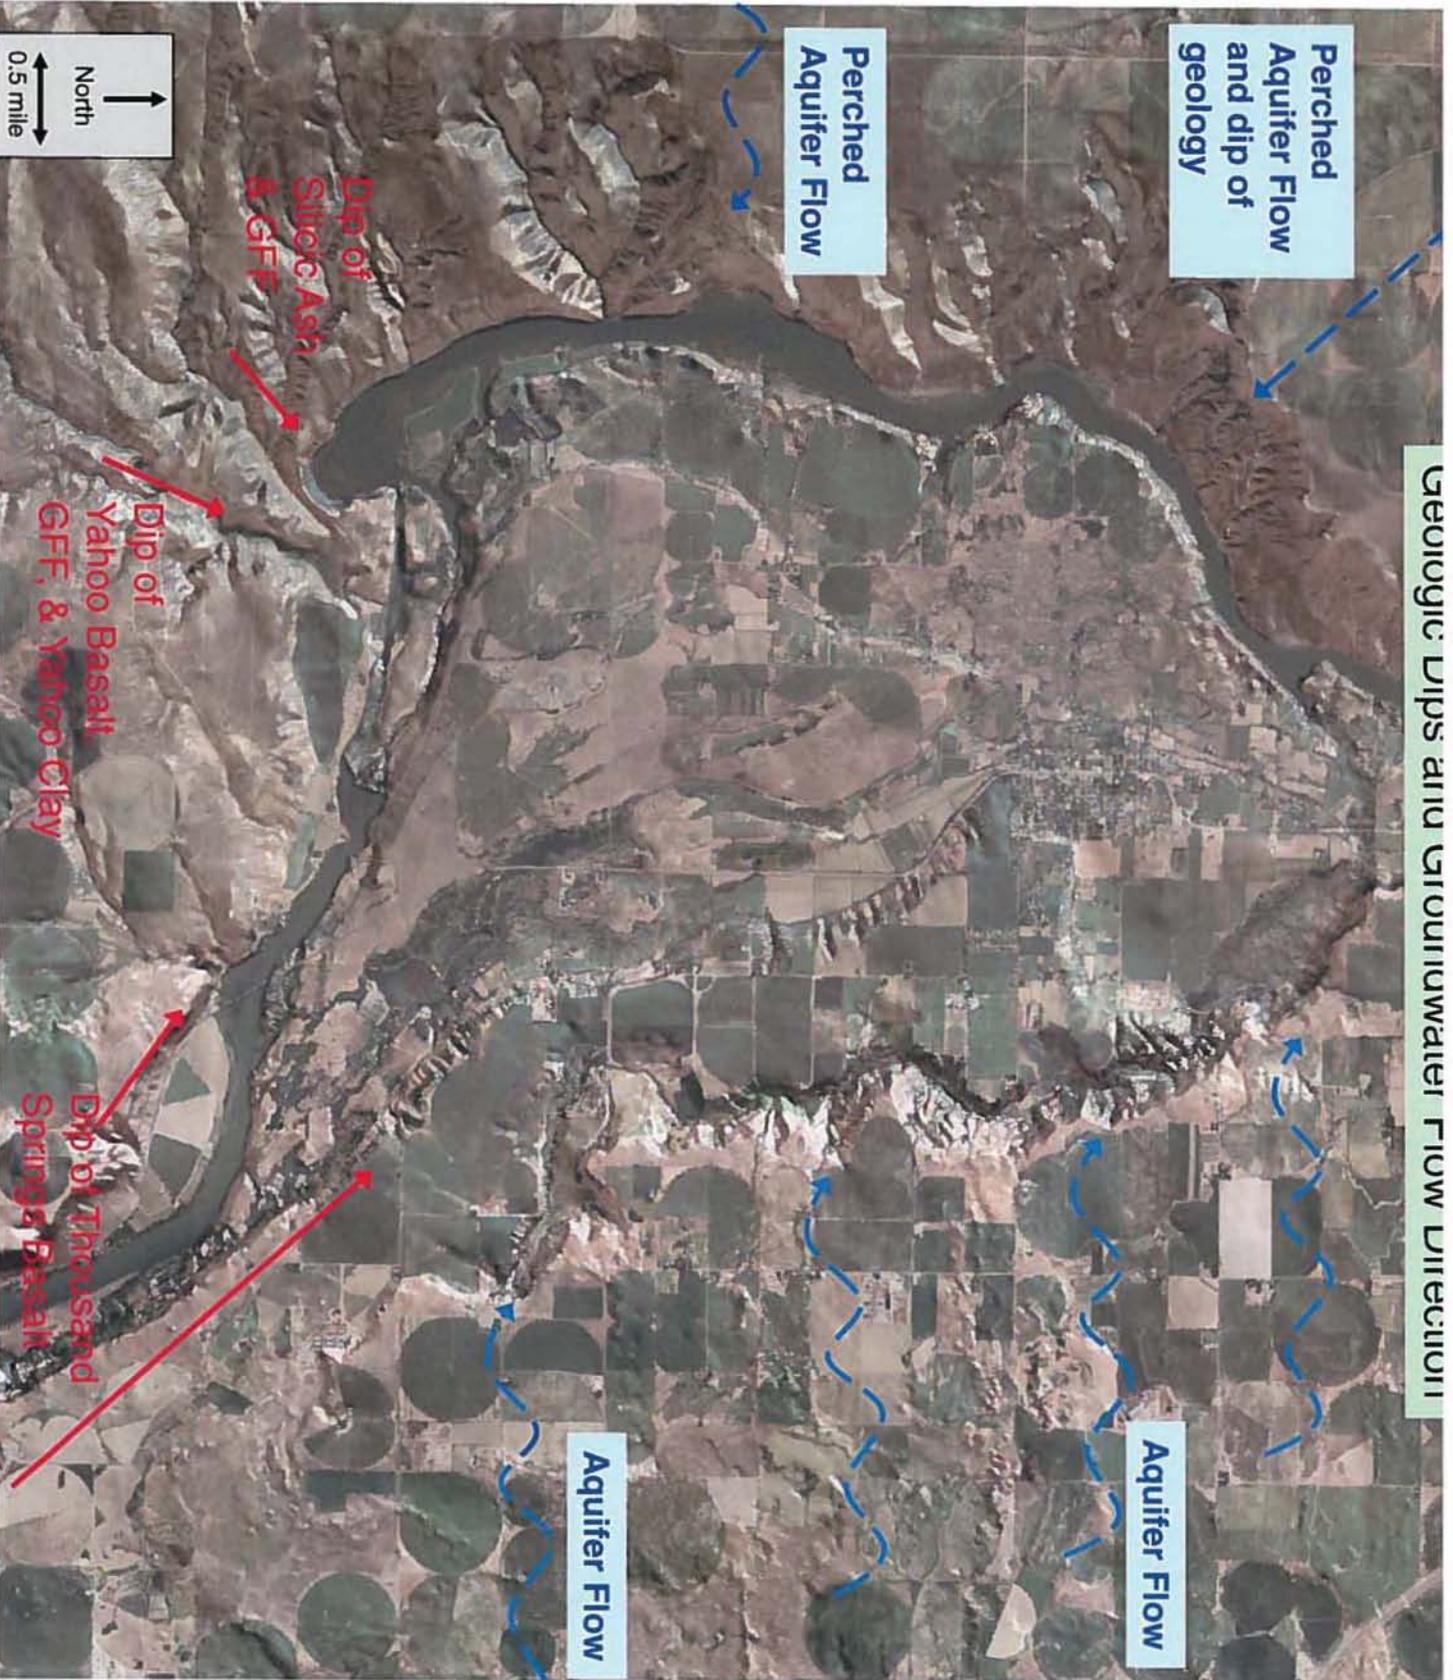
Geologic dips and groundwater flow direction

Flourescent dye groundwater tracer tests document direction of groundwater flow is to southeast at up to 250 feet per day in Tertiary age 'brown' basalt, sometimes thought to have low permeability.

Surveyed geologic outcrops and well logs in this area support a southeast dipping architecture with in the lake sediments.

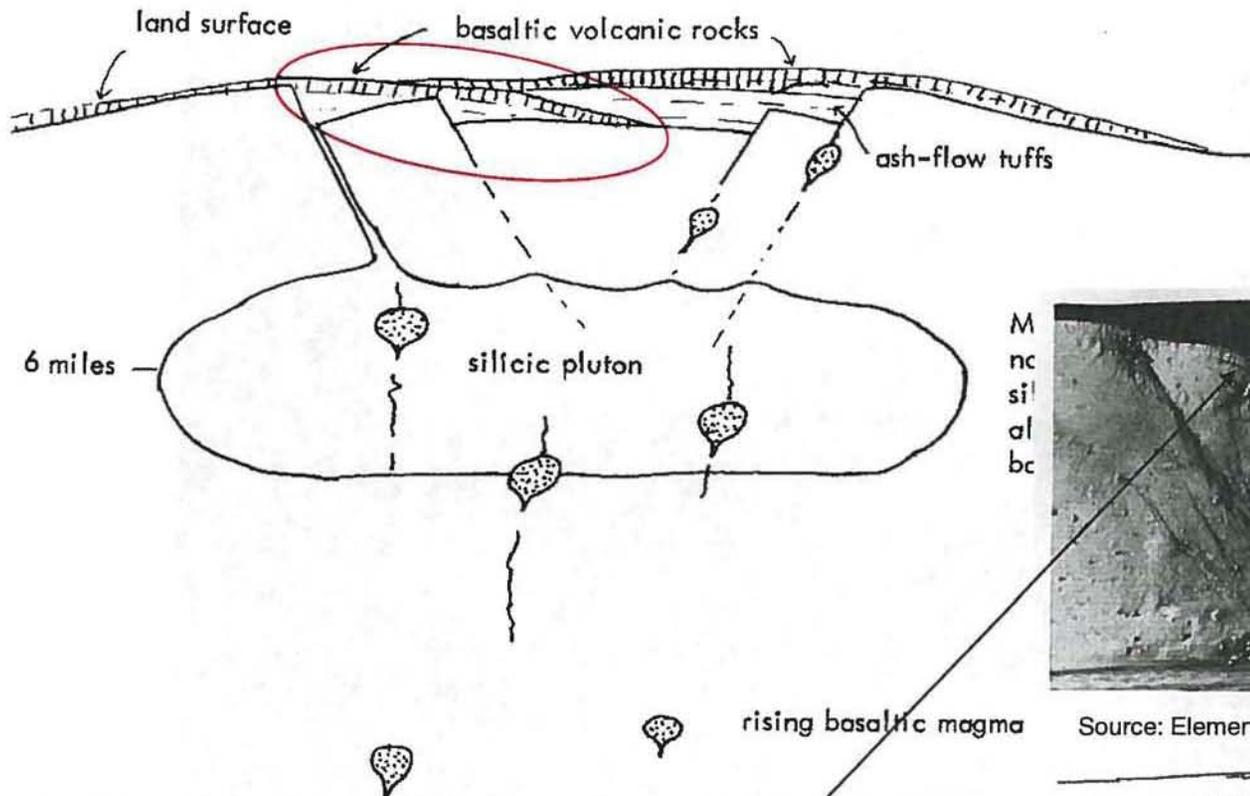
Idealized Caldera Collapse Structure as a Possible Model

(from Terry Maley 'Exploring Idaho Geology', 1987)

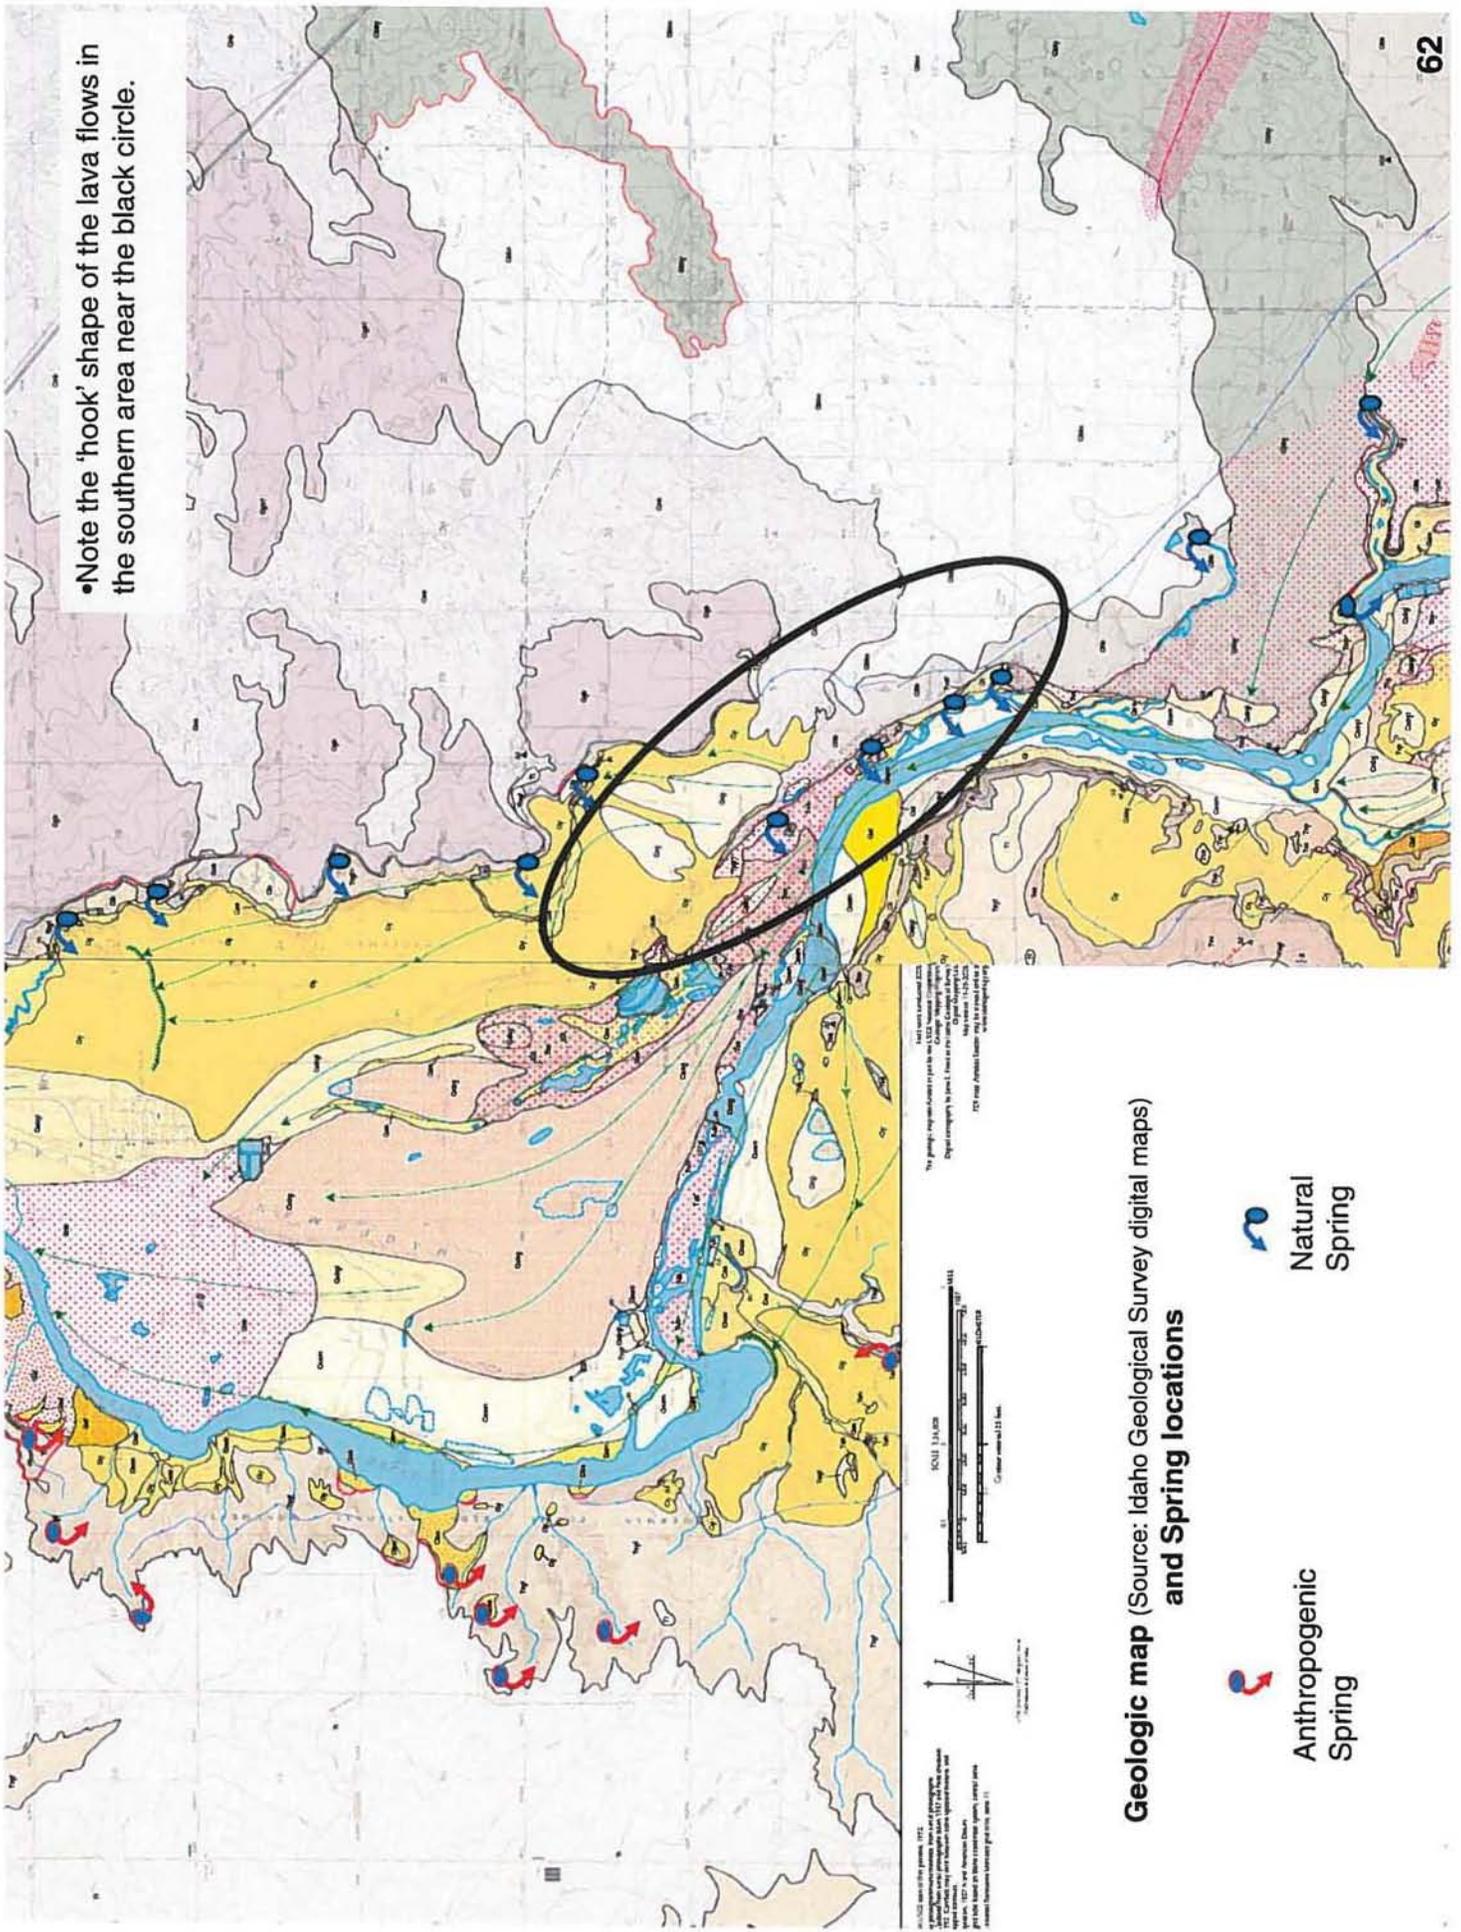
•Note the 'hook' shape of the lava flows in the southern area near the black circle.

Geologic map (Source: Idaho Geological Survey digital maps and Spring locations)
