Hagerman Valley Geology

The Effect of Large-scale Heterogeneities and Geologic Structures on Spring Spatial Distribution

By: Neal Farmer

Idaho Department of Water Resources

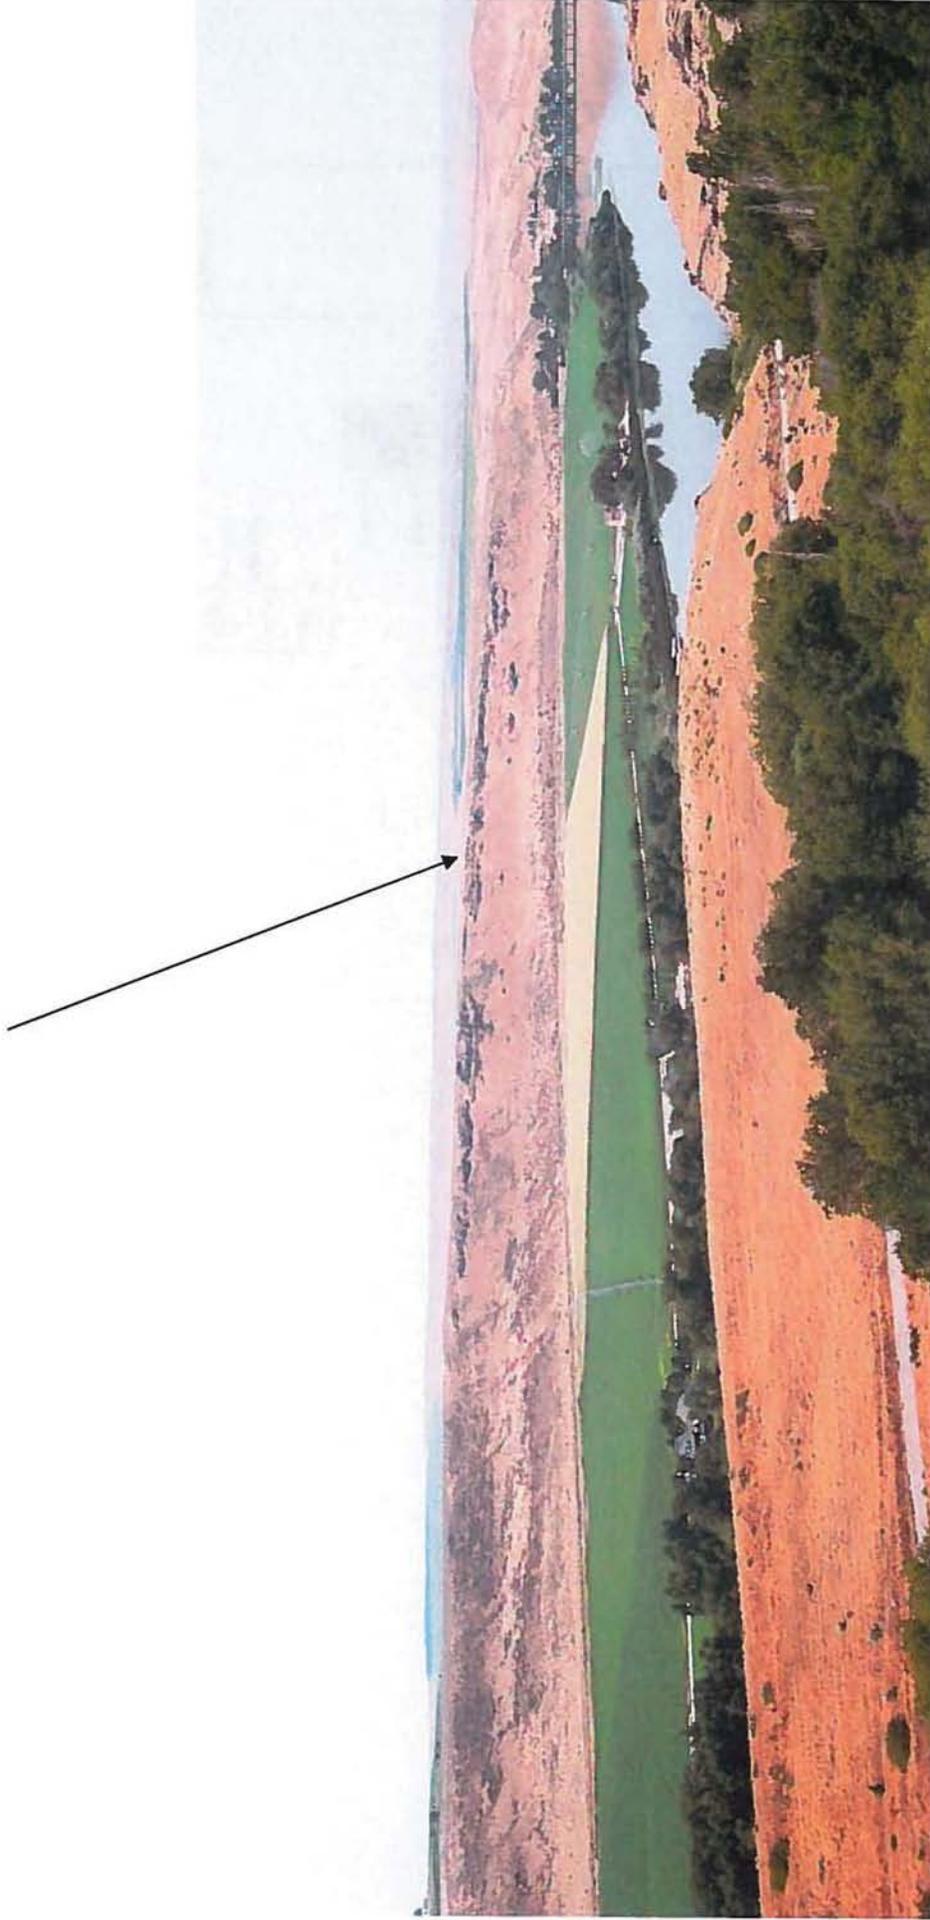
Northwest Dipping Basalt on west side of Snake River

(view azimuth is to the west from National Fish Hatchery)

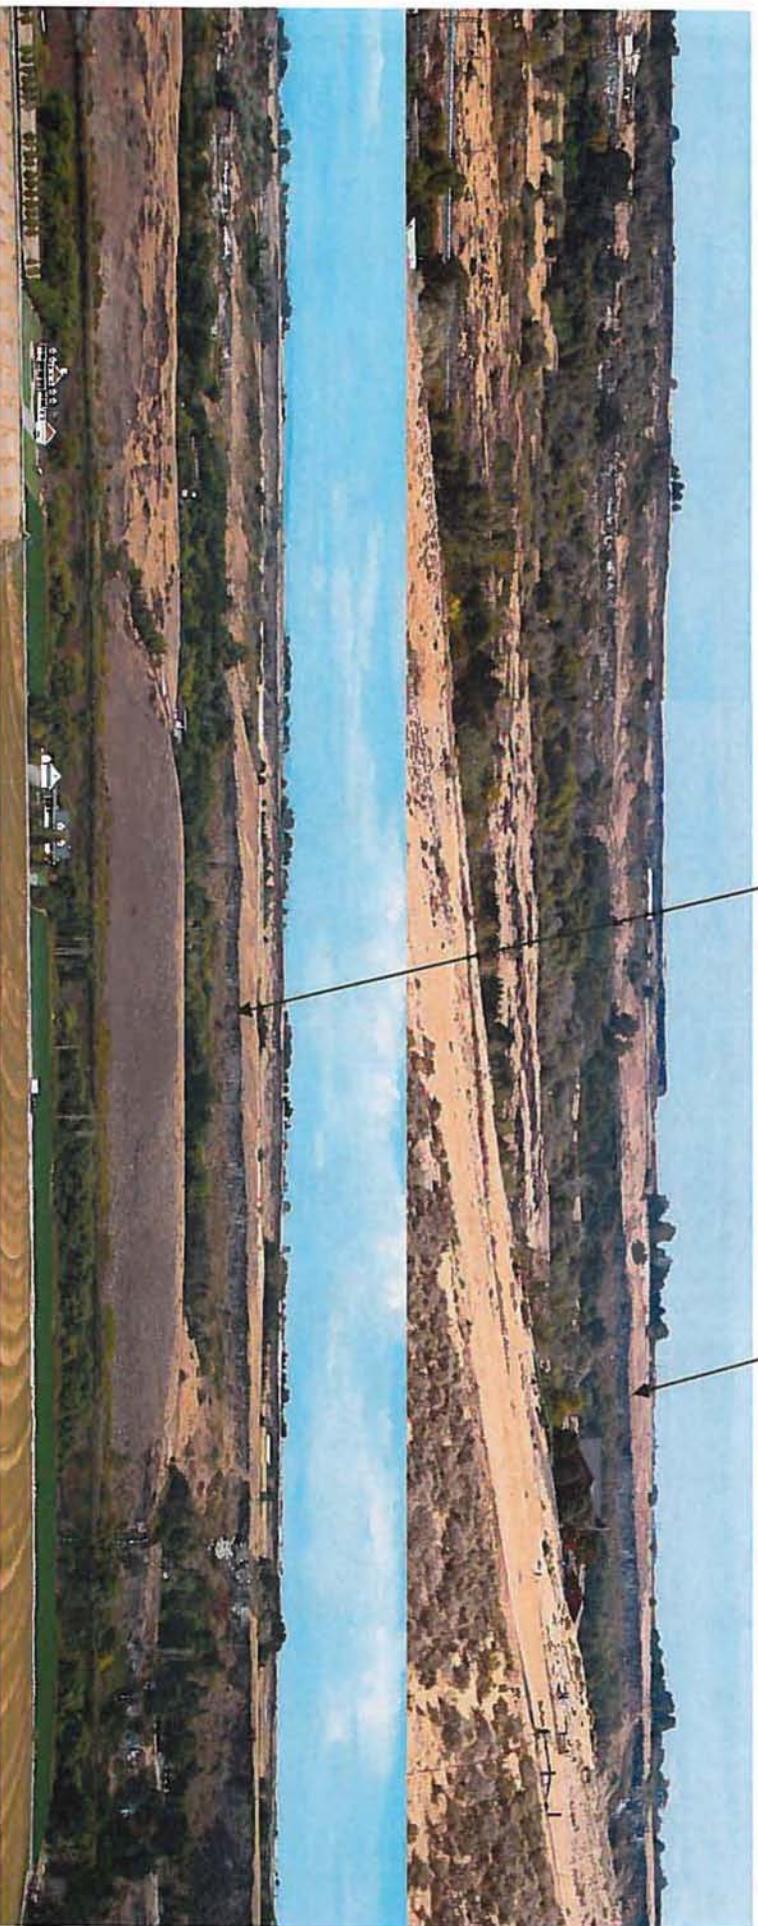
Northwest Dipping Basalt near Thousand Springs
(view azimuth is east)

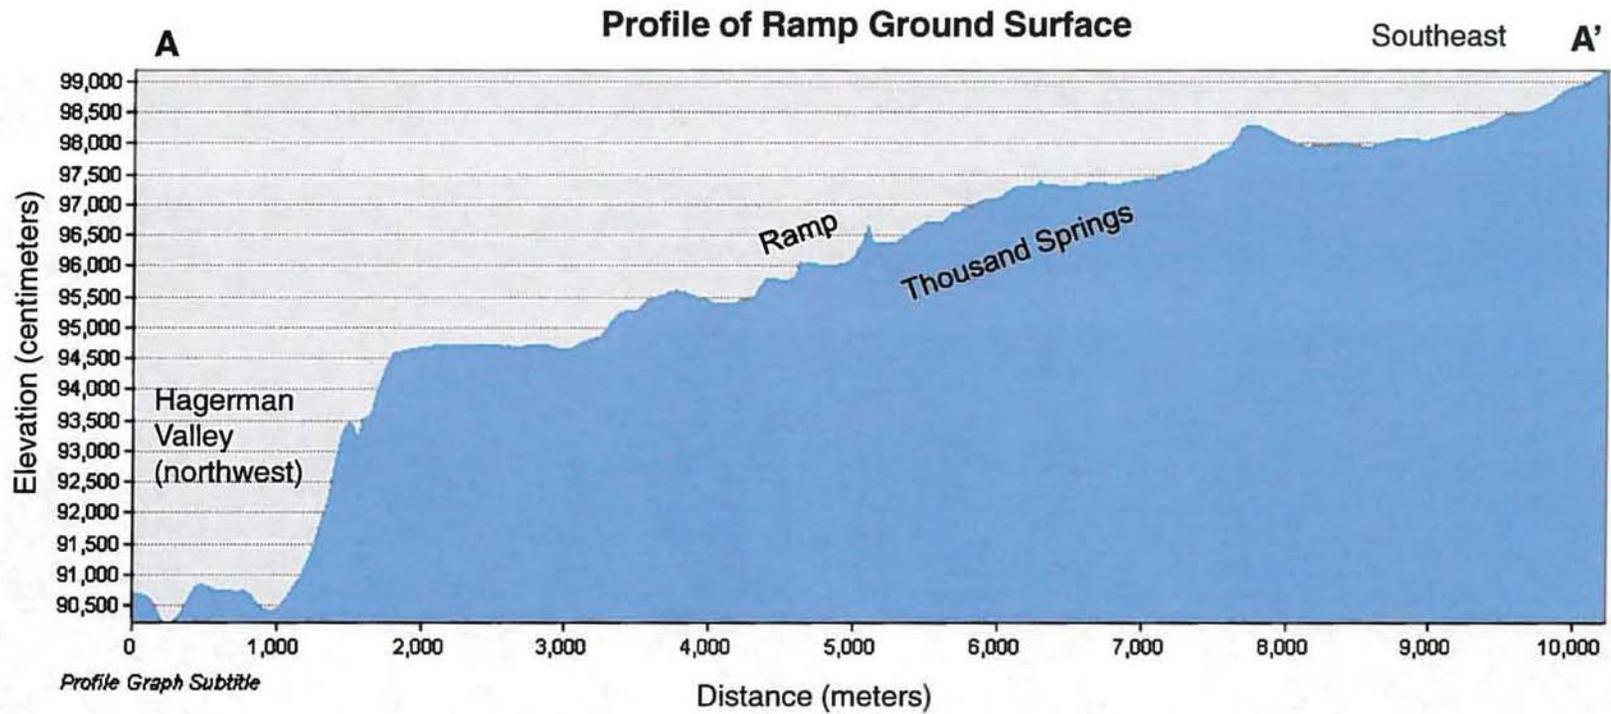
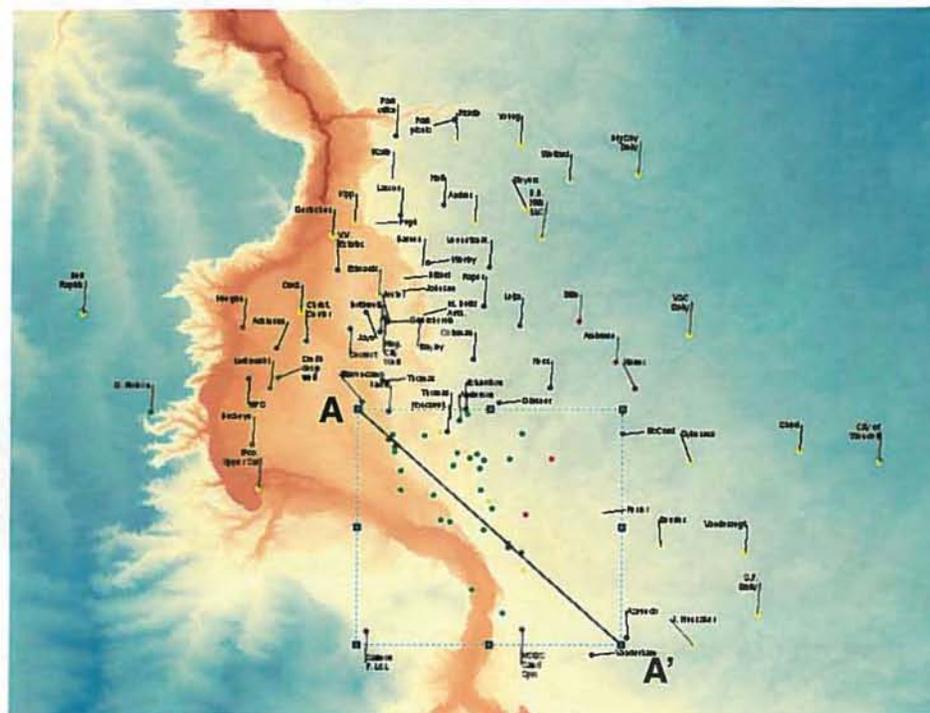
Thousand Springs – note the dip of the springs and contact.

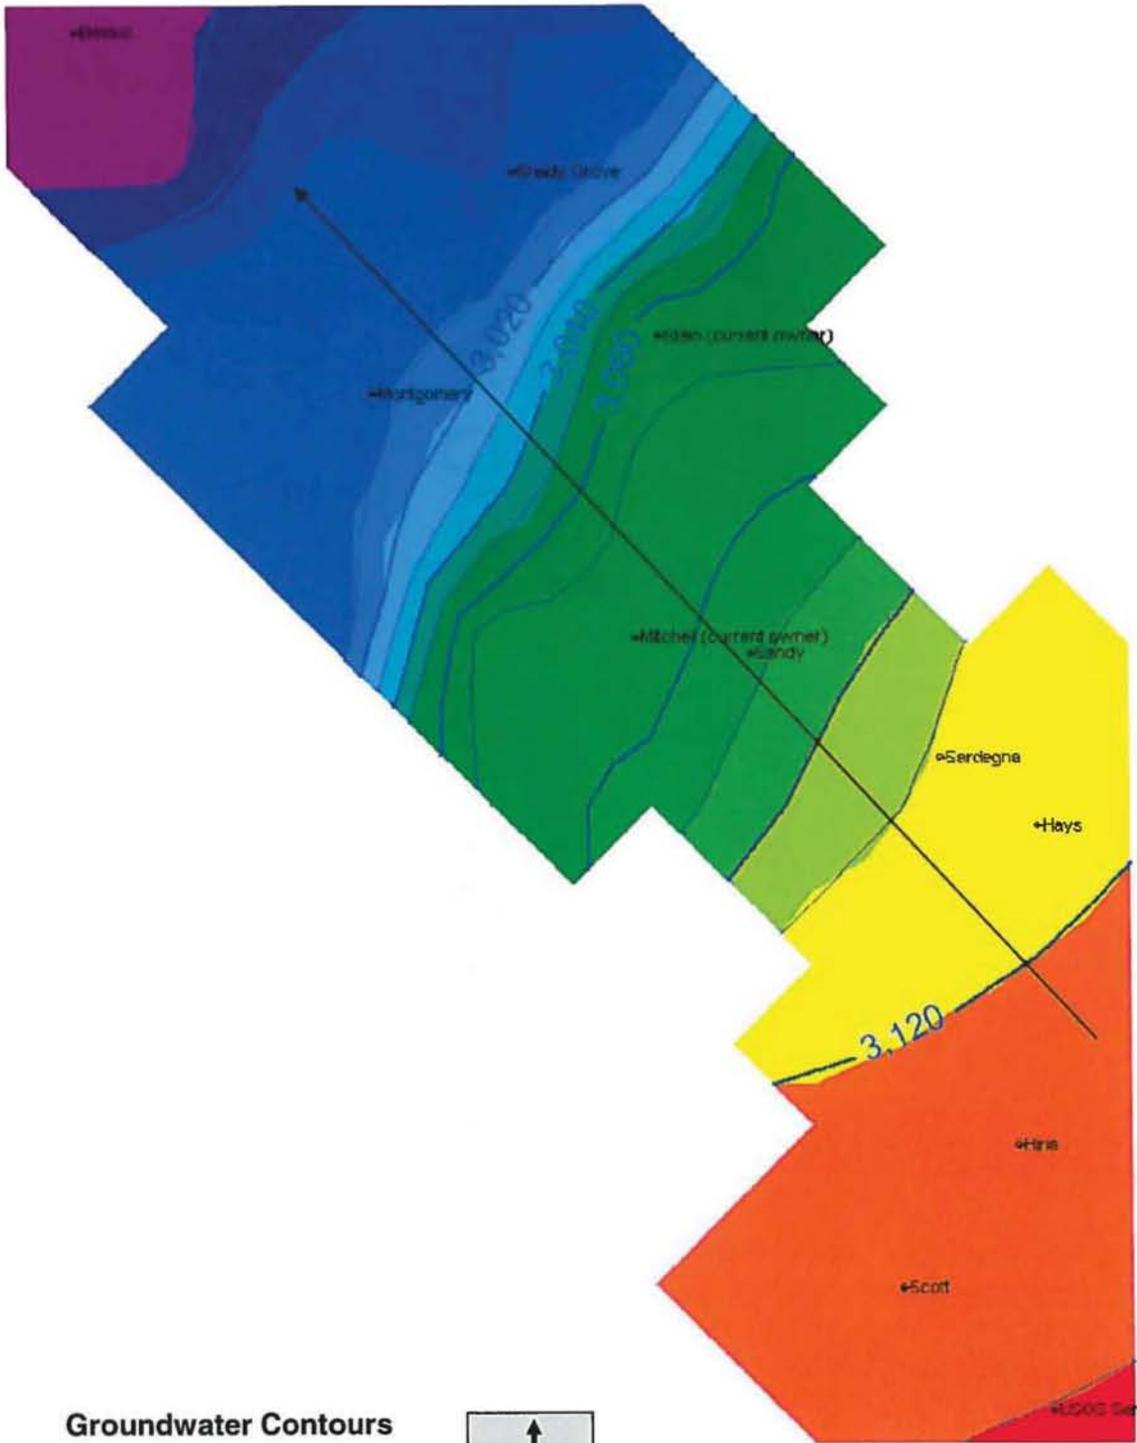
**Groundwater Contours
down 'Ramp' Structure
with flow line.**

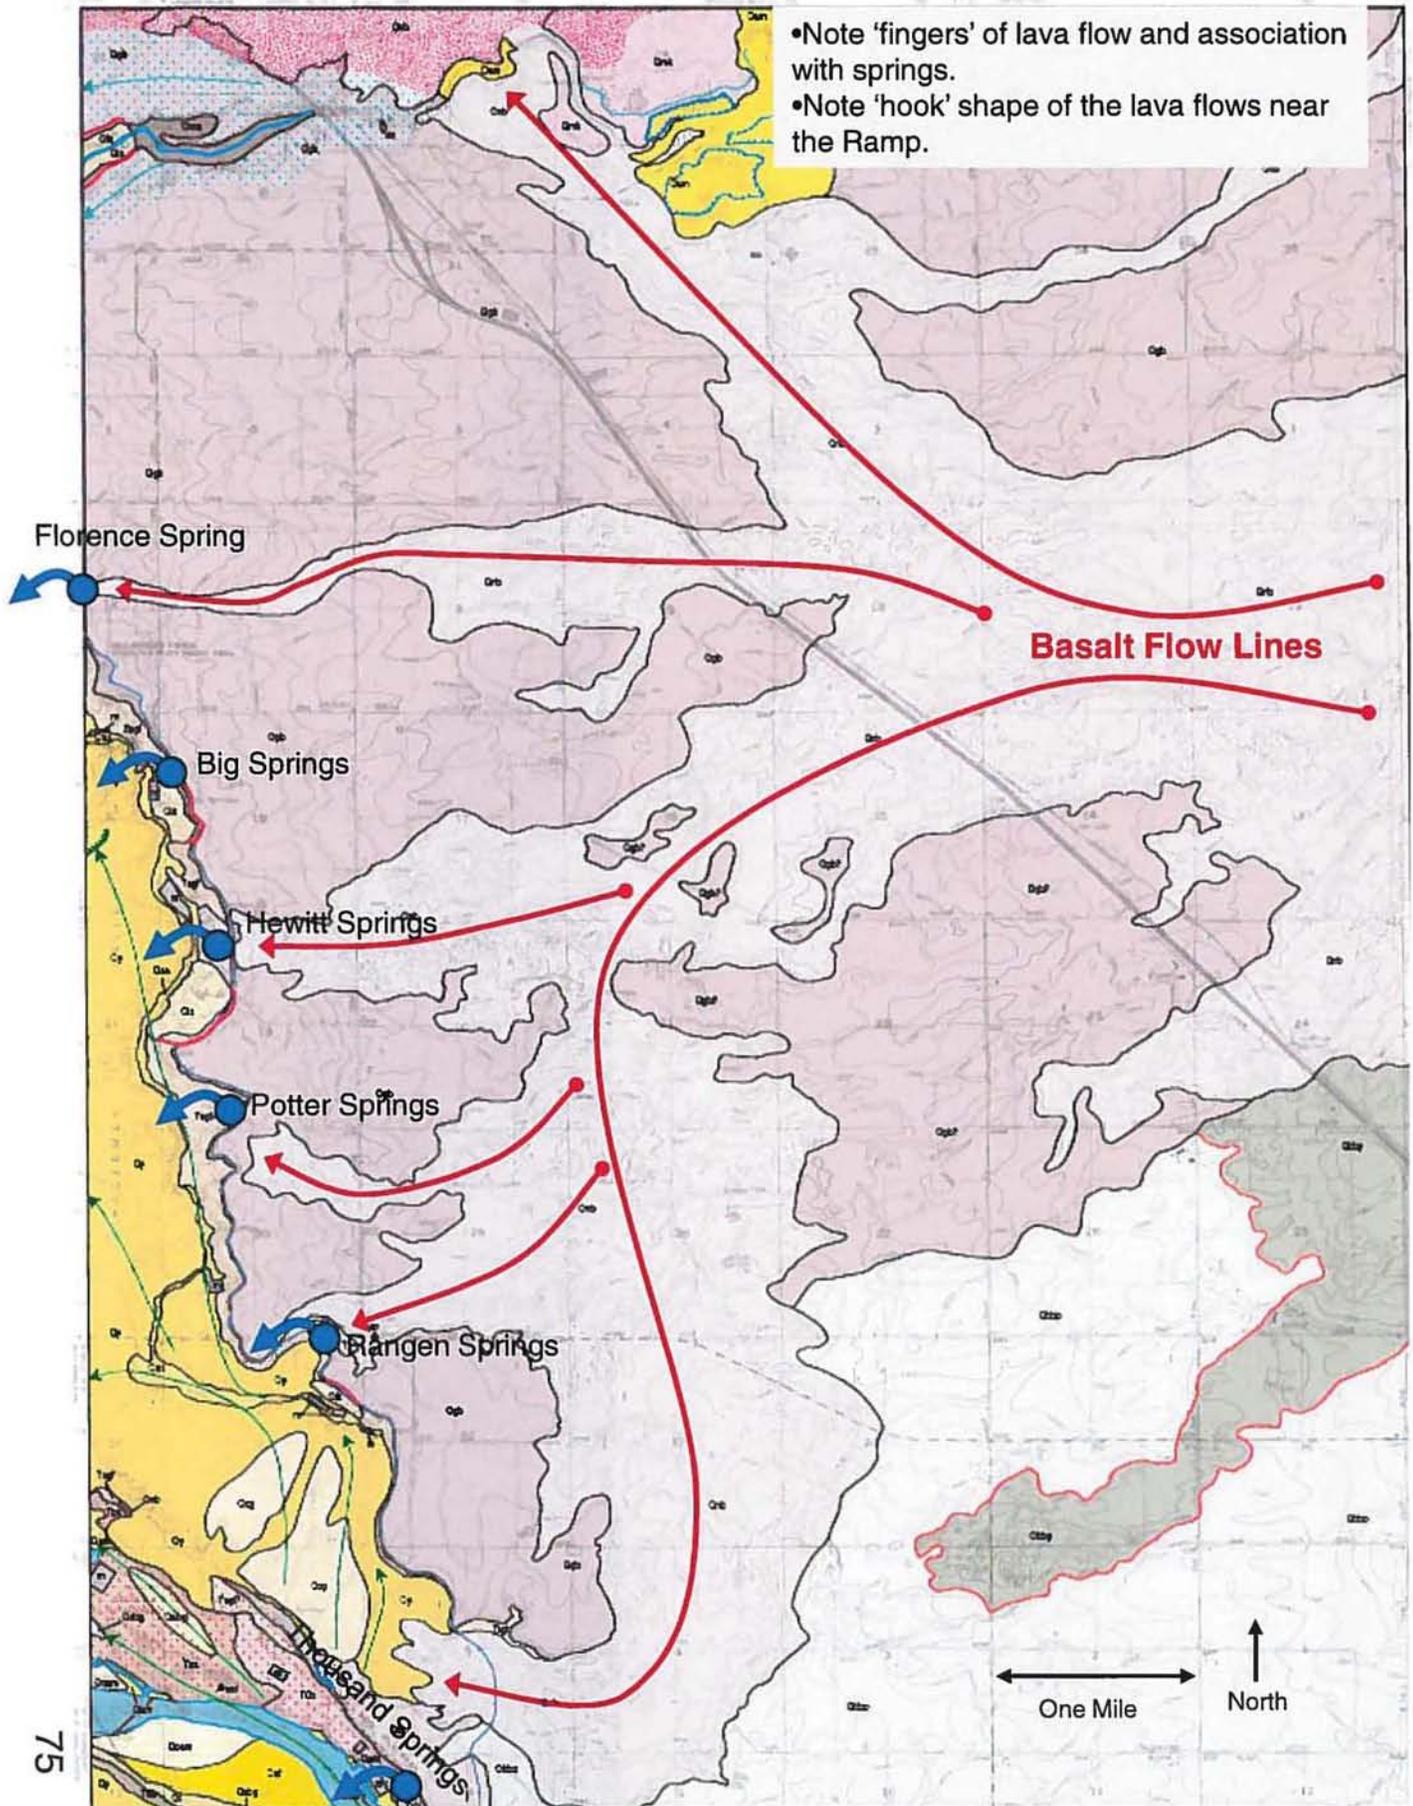
- Note 'fingers' of lava flow and association with springs.
- Note 'hook' shape of the lava flows near the Ramp.

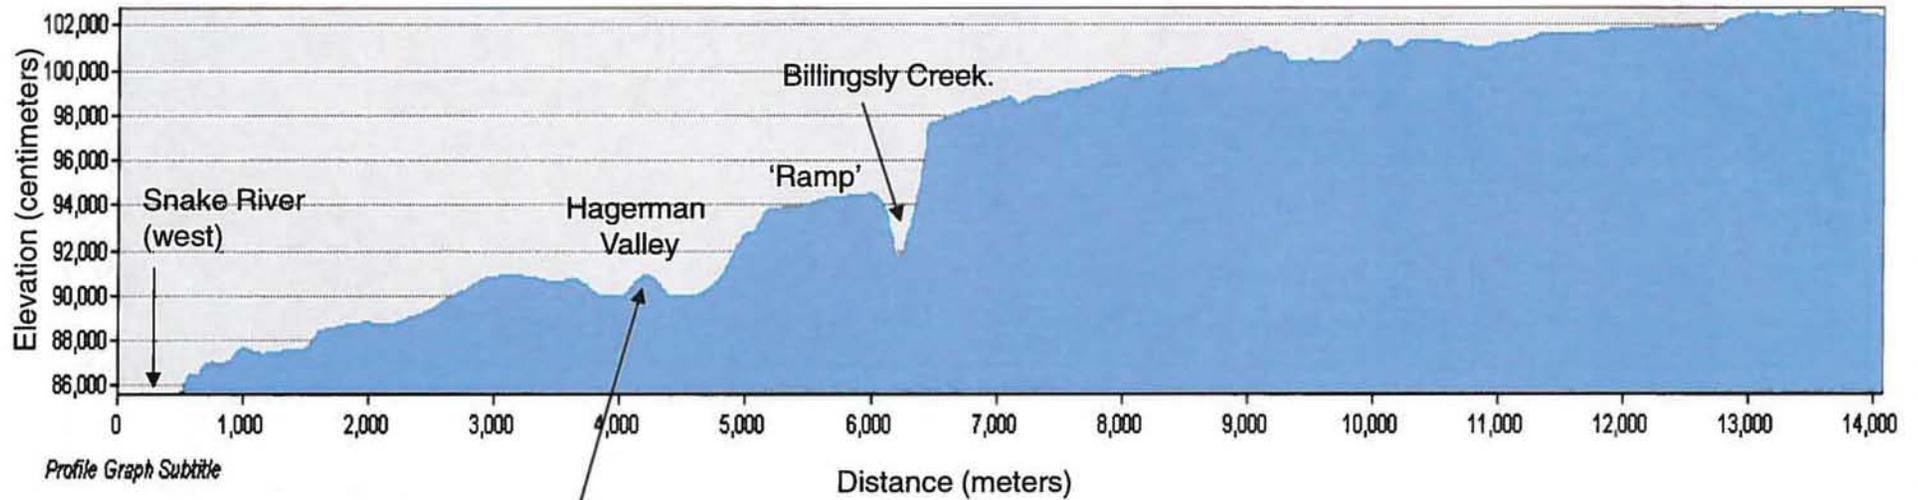
East/West Profile of Land Surface

City of Wendell
(east)

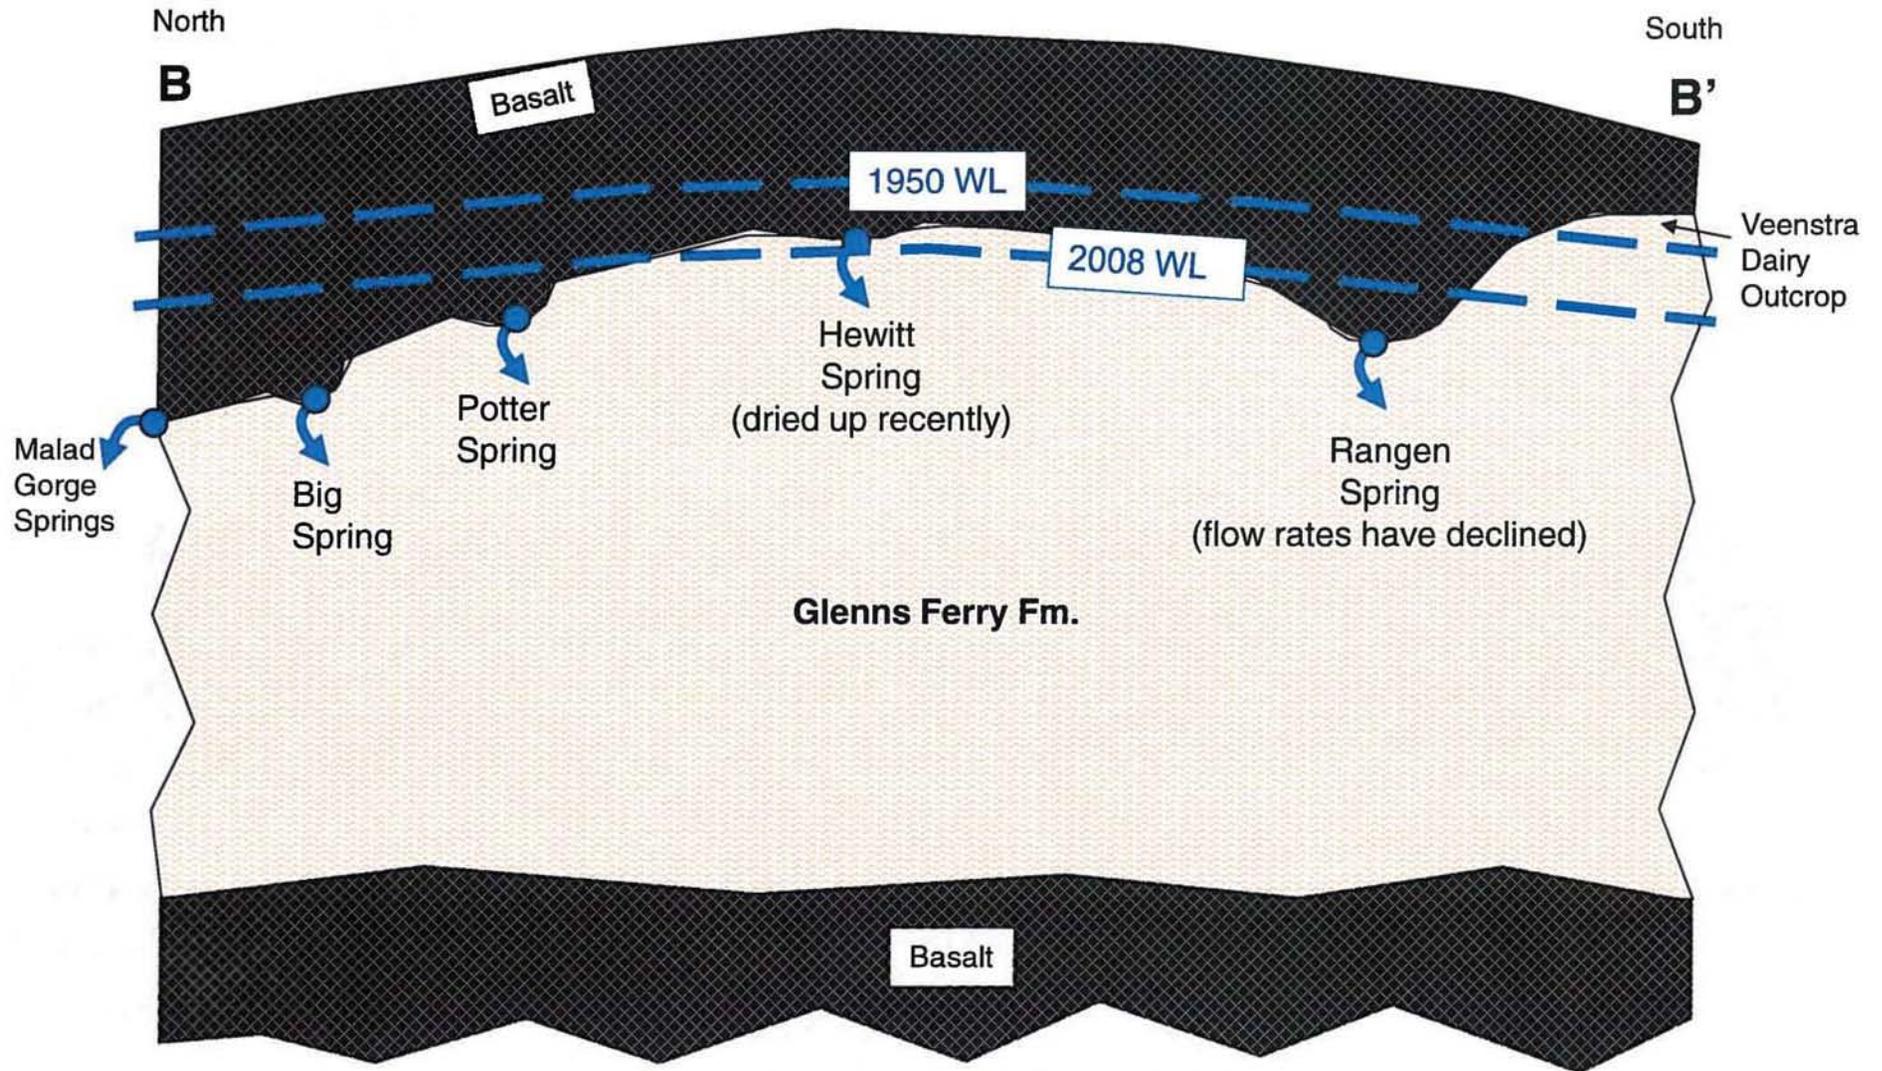
Conceptual Block Diagram

Ground surface profile from Malad Gorge to Thousand Springs area showing a arched feature which correlates to the groundwater contours.

(vertical and horizontal are not to scale)

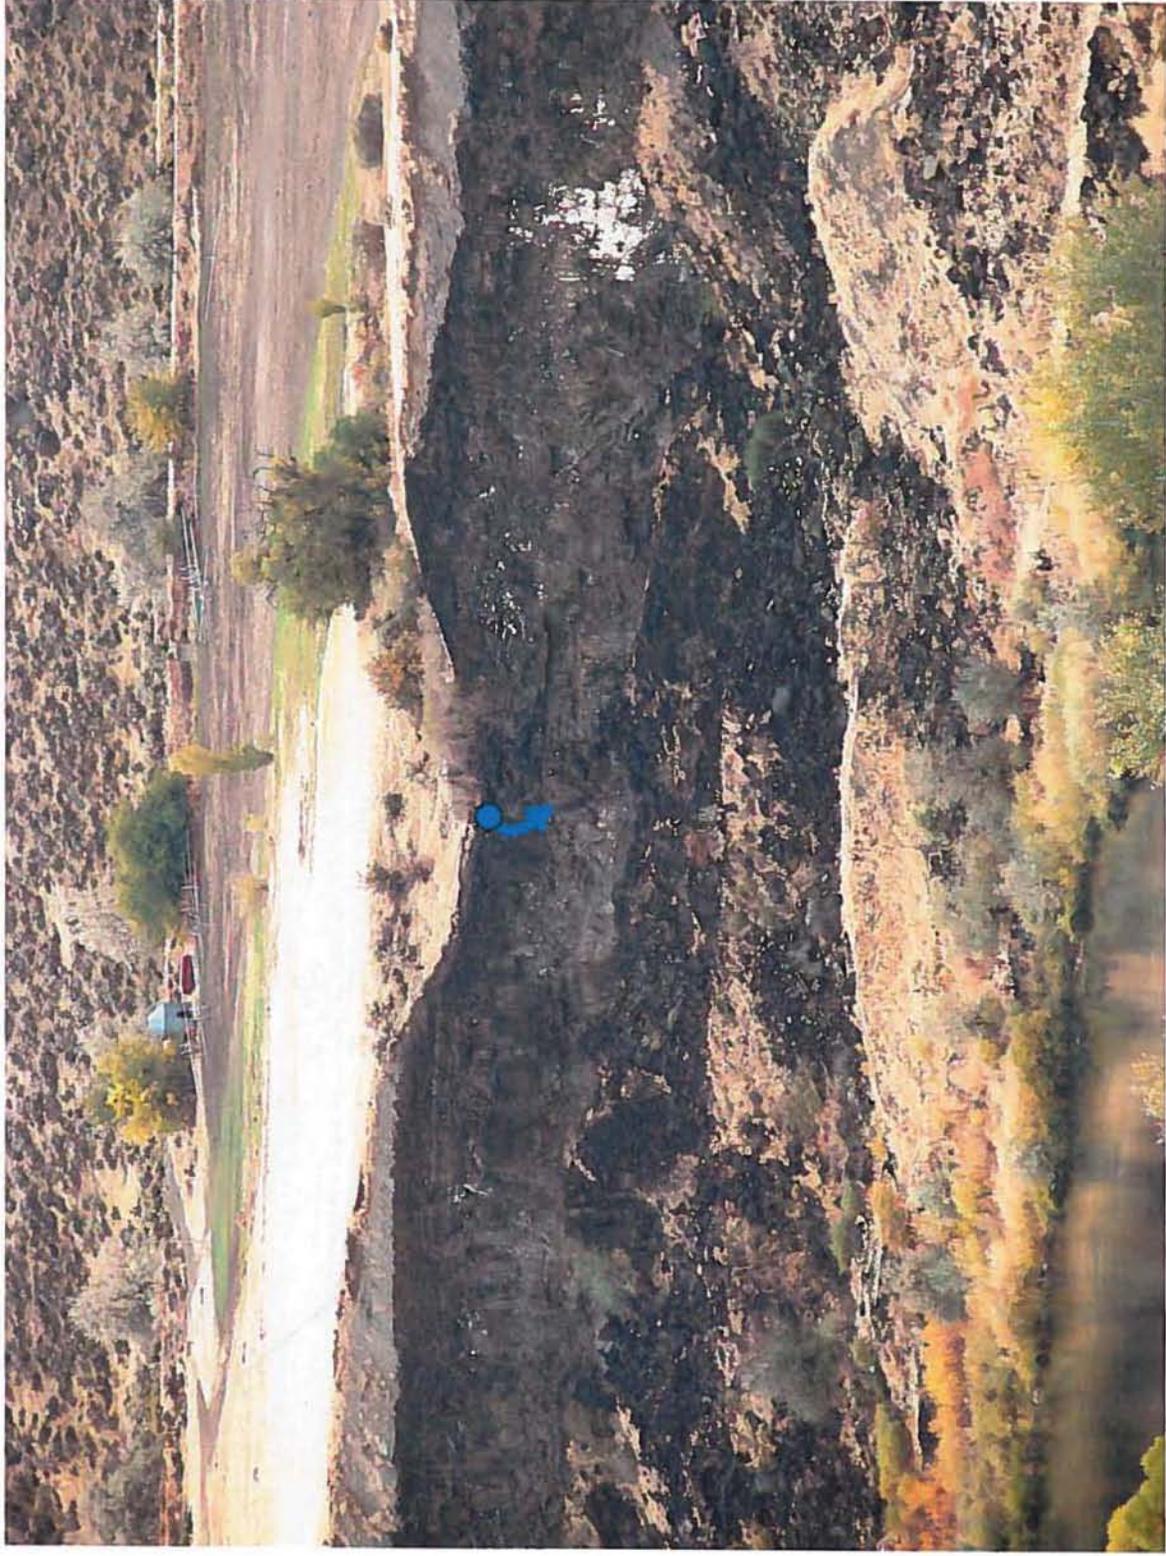
Outcrop example of a paleo-topographic low depression which groundwater may prefer to follow but this is a reverse geology of Rangen site and no groundwater is discharging here.

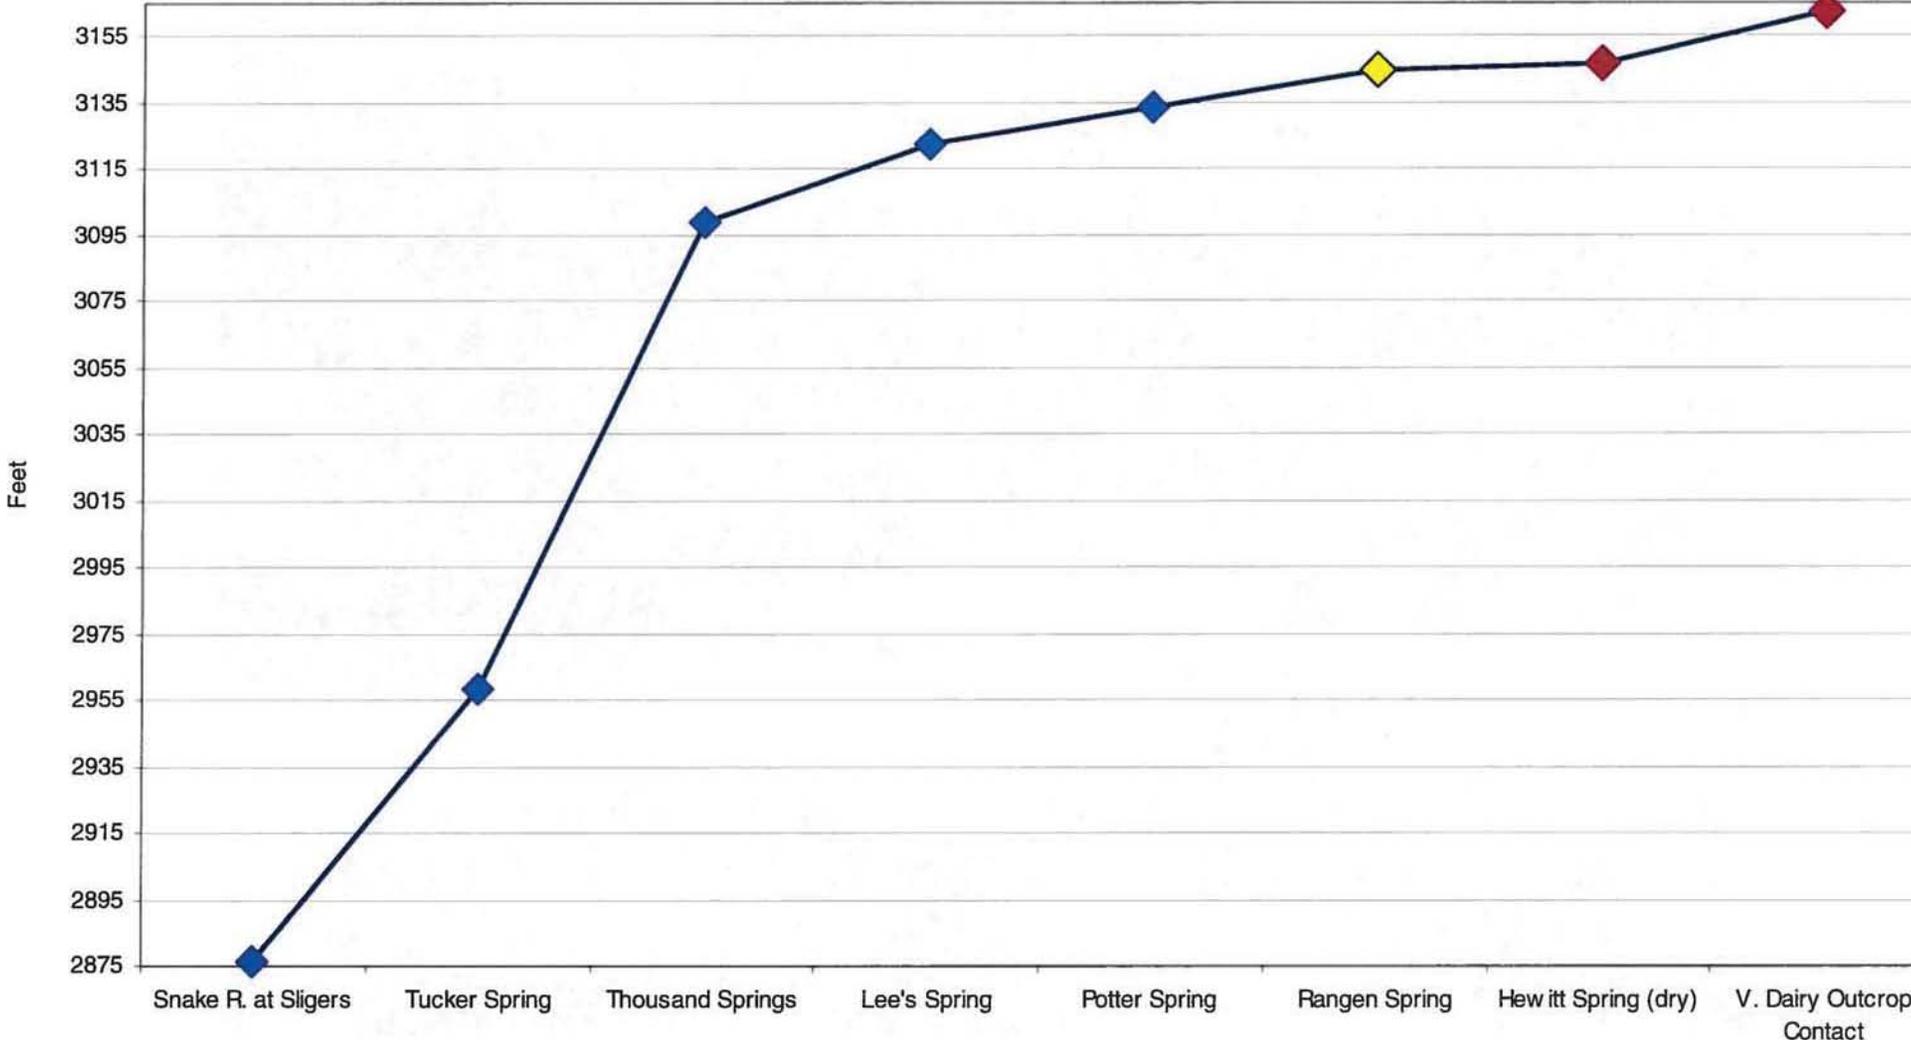
Elevations of springs and one outcrop contact showing how higher elevation springs are drying up.

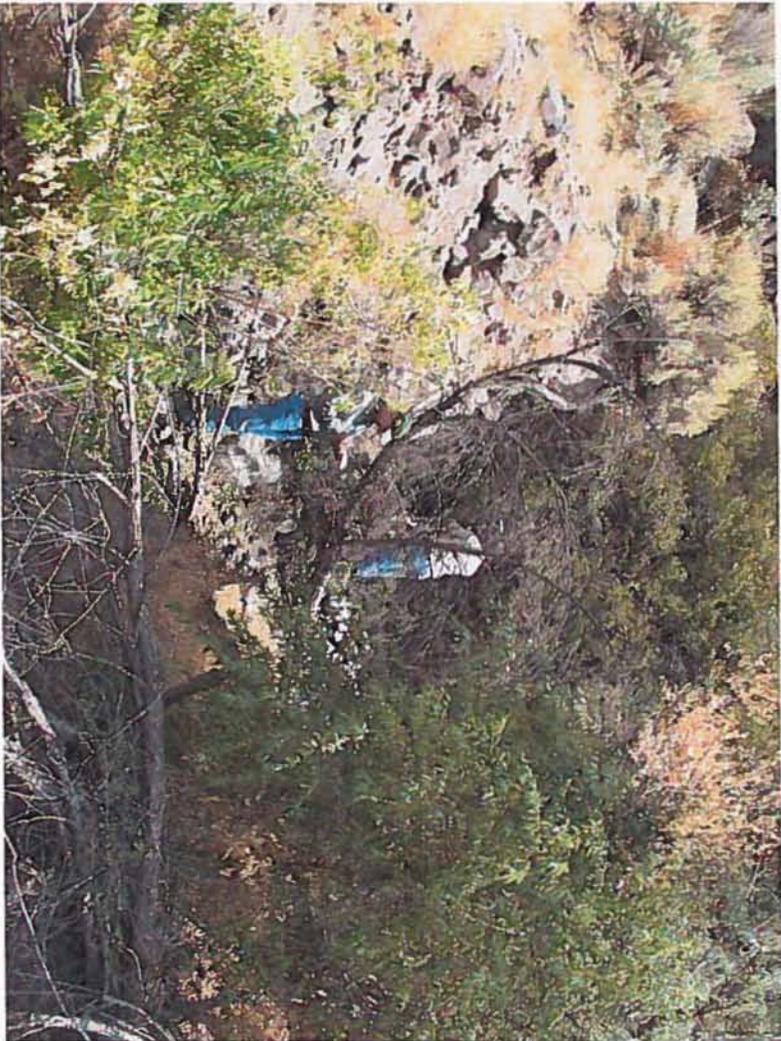
Hewitt Spring (dry)

The groundwater table has dropped below the elevation of the spring.

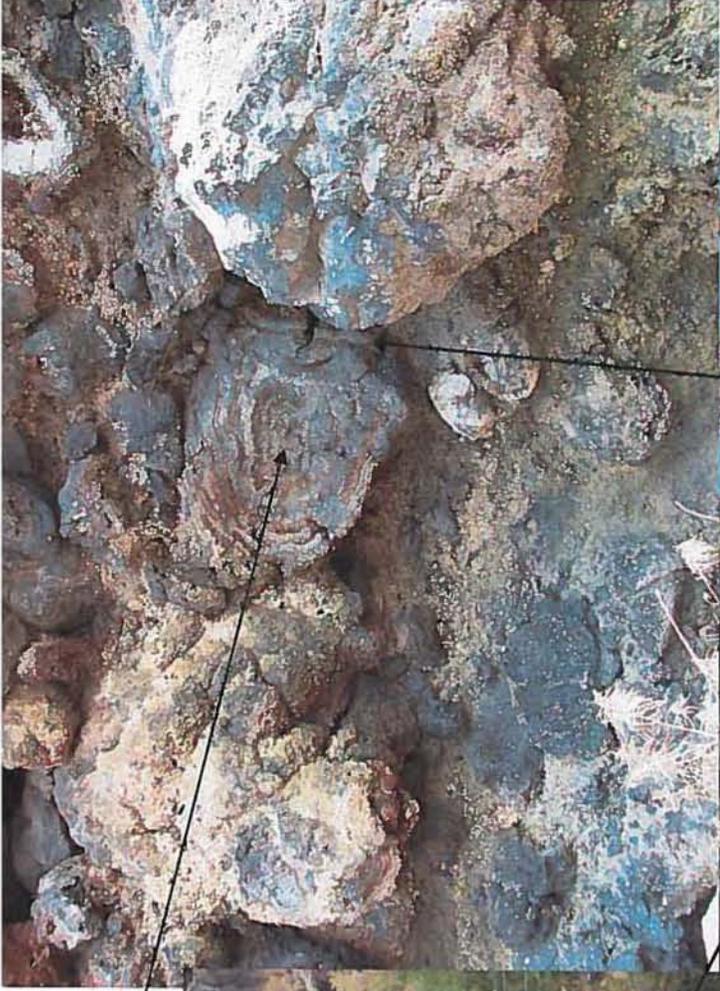
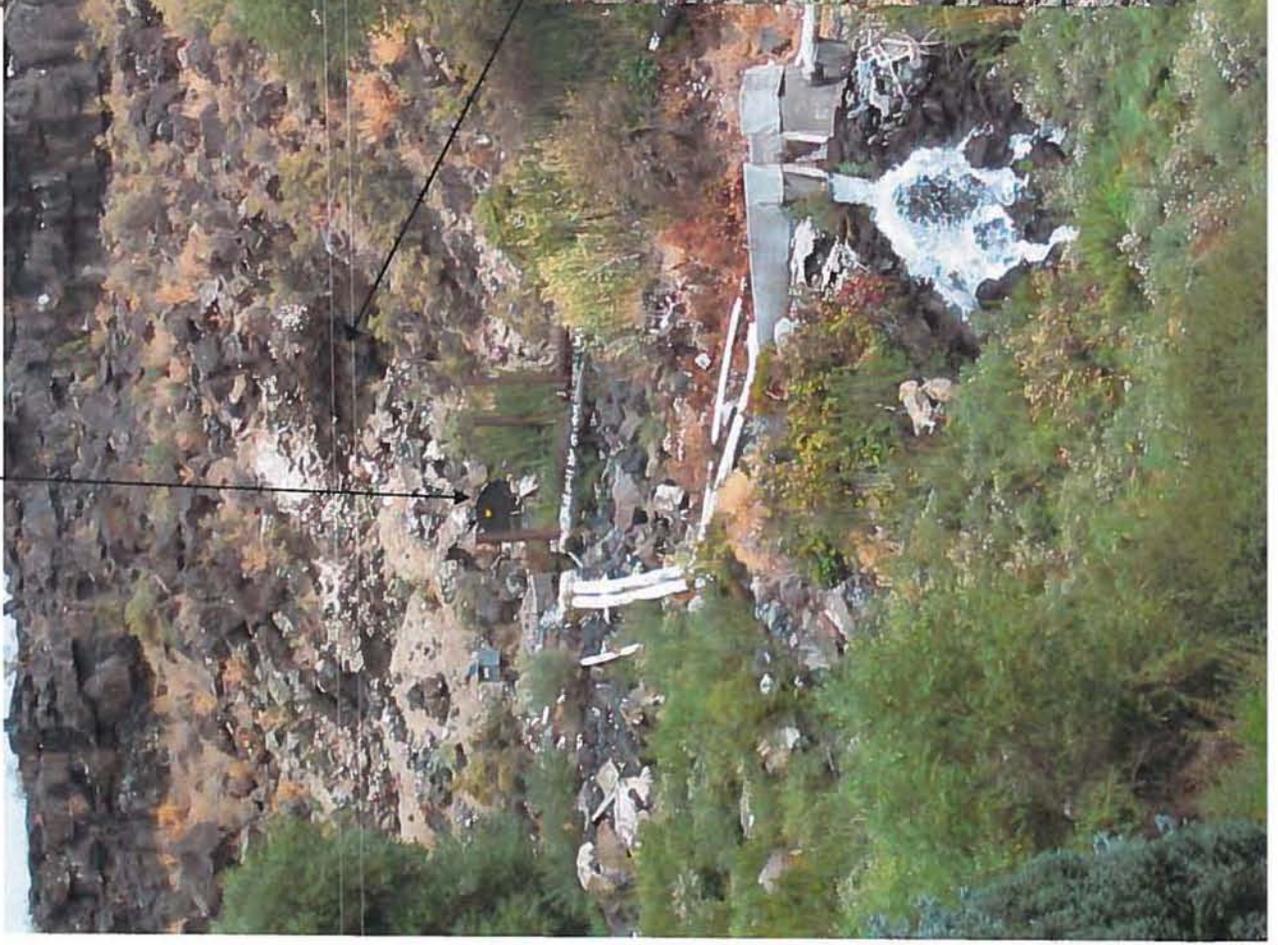
**Rangen Spring – compare to Veenstra Dairy
Geologic outcrop.**

'Pillow Lava' –
formed when lava
flows into water.

Tunnel to enhance spring flow

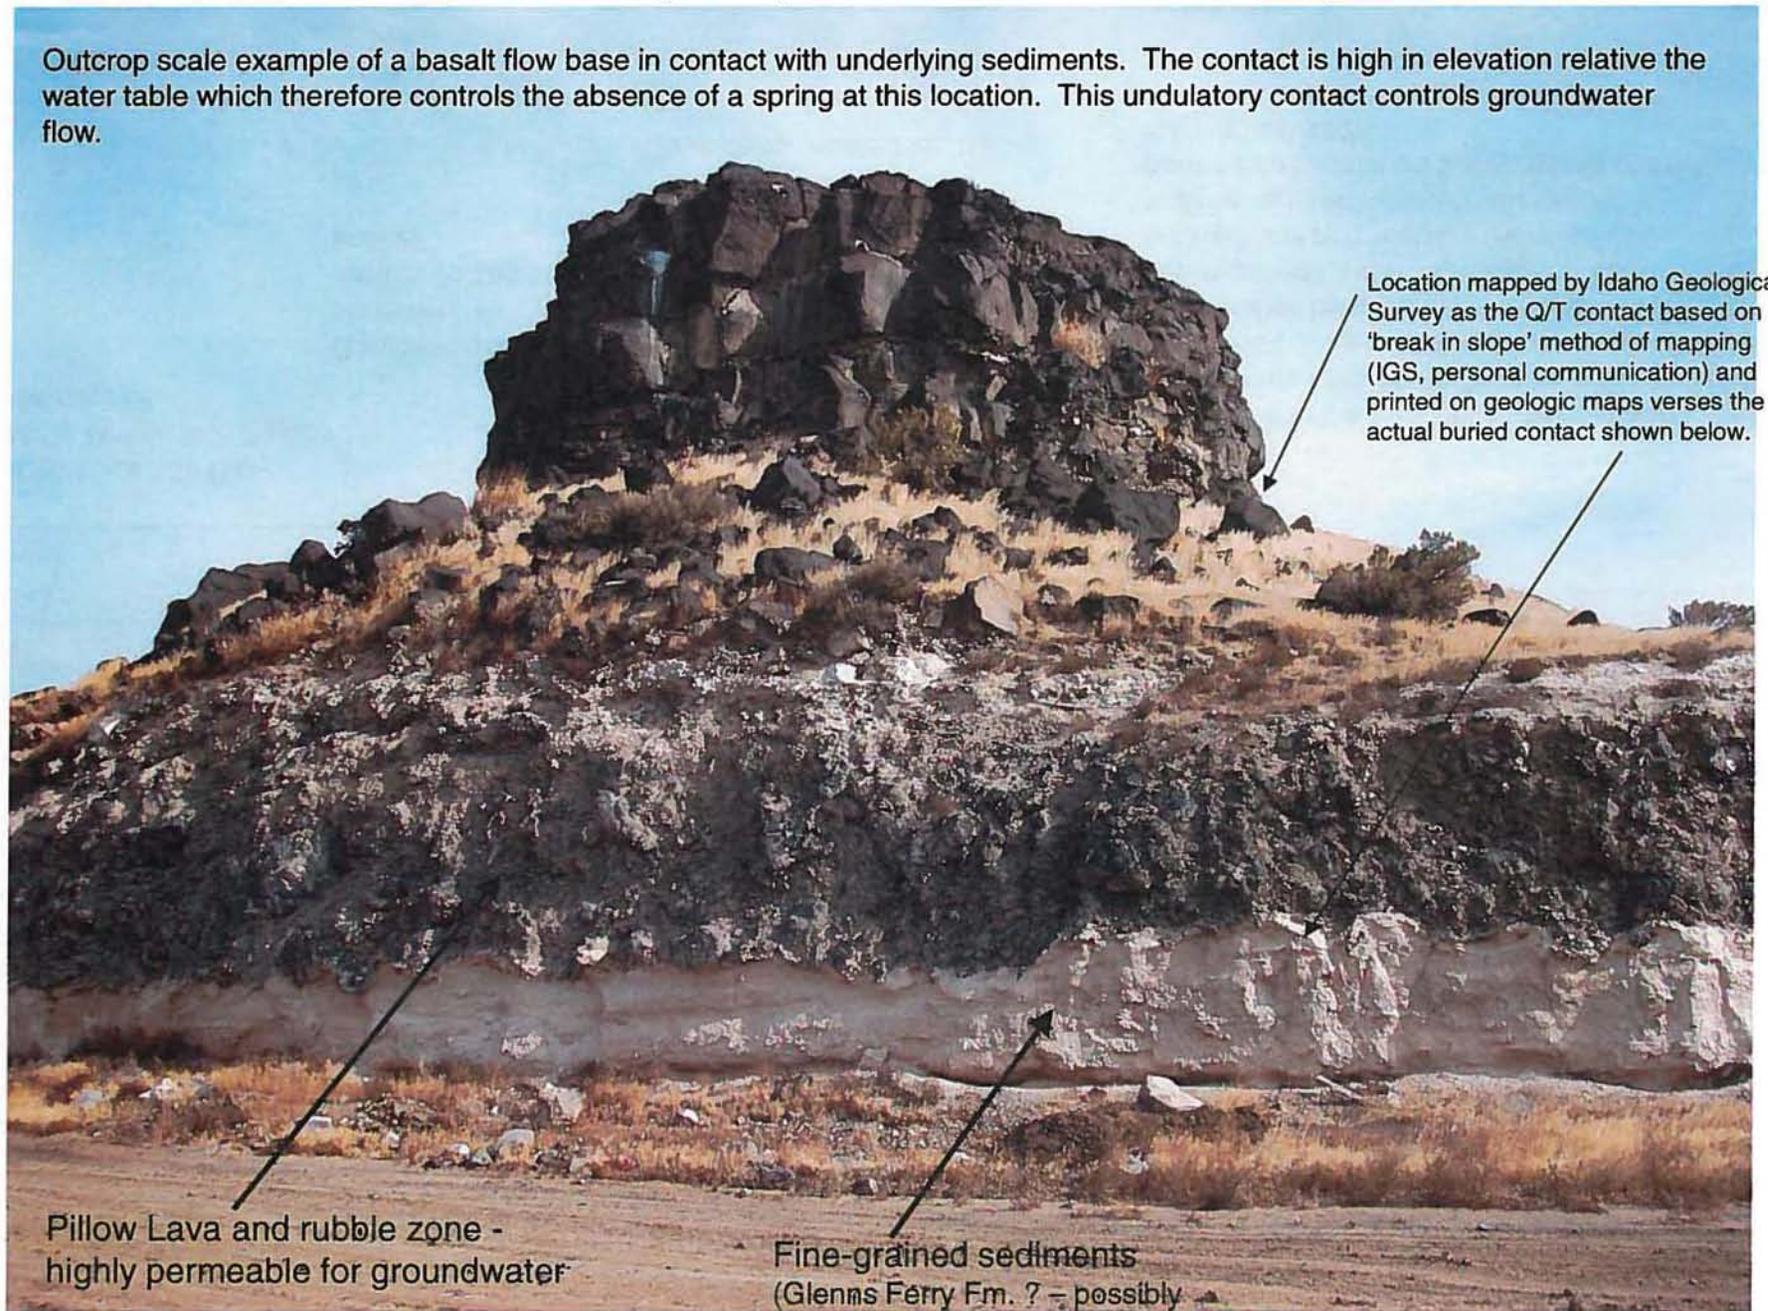
Veenstra Dairy outcrop contact south of Vader Grade outcrop.

Outcrop scale example of a basalt flow base in contact with underlying sediments. The contact is high in elevation relative the water table which therefore controls the absence of a spring at this location. This undulatory contact controls groundwater flow.

Location mapped by Idaho Geological Survey as the Q/T contact based on 'break in slope' method of mapping (IGS, personal communication) and printed on geologic maps versus the actual buried contact shown below.

Pillow Lava and rubble zone - highly permeable for groundwater
