Hagerman Valley Geology

The Effect of Large-scale Heterogeneities and Geologic Structures on Spring Spatial Distribution

By: Neal Farmer

Idaho Department of Water Resources

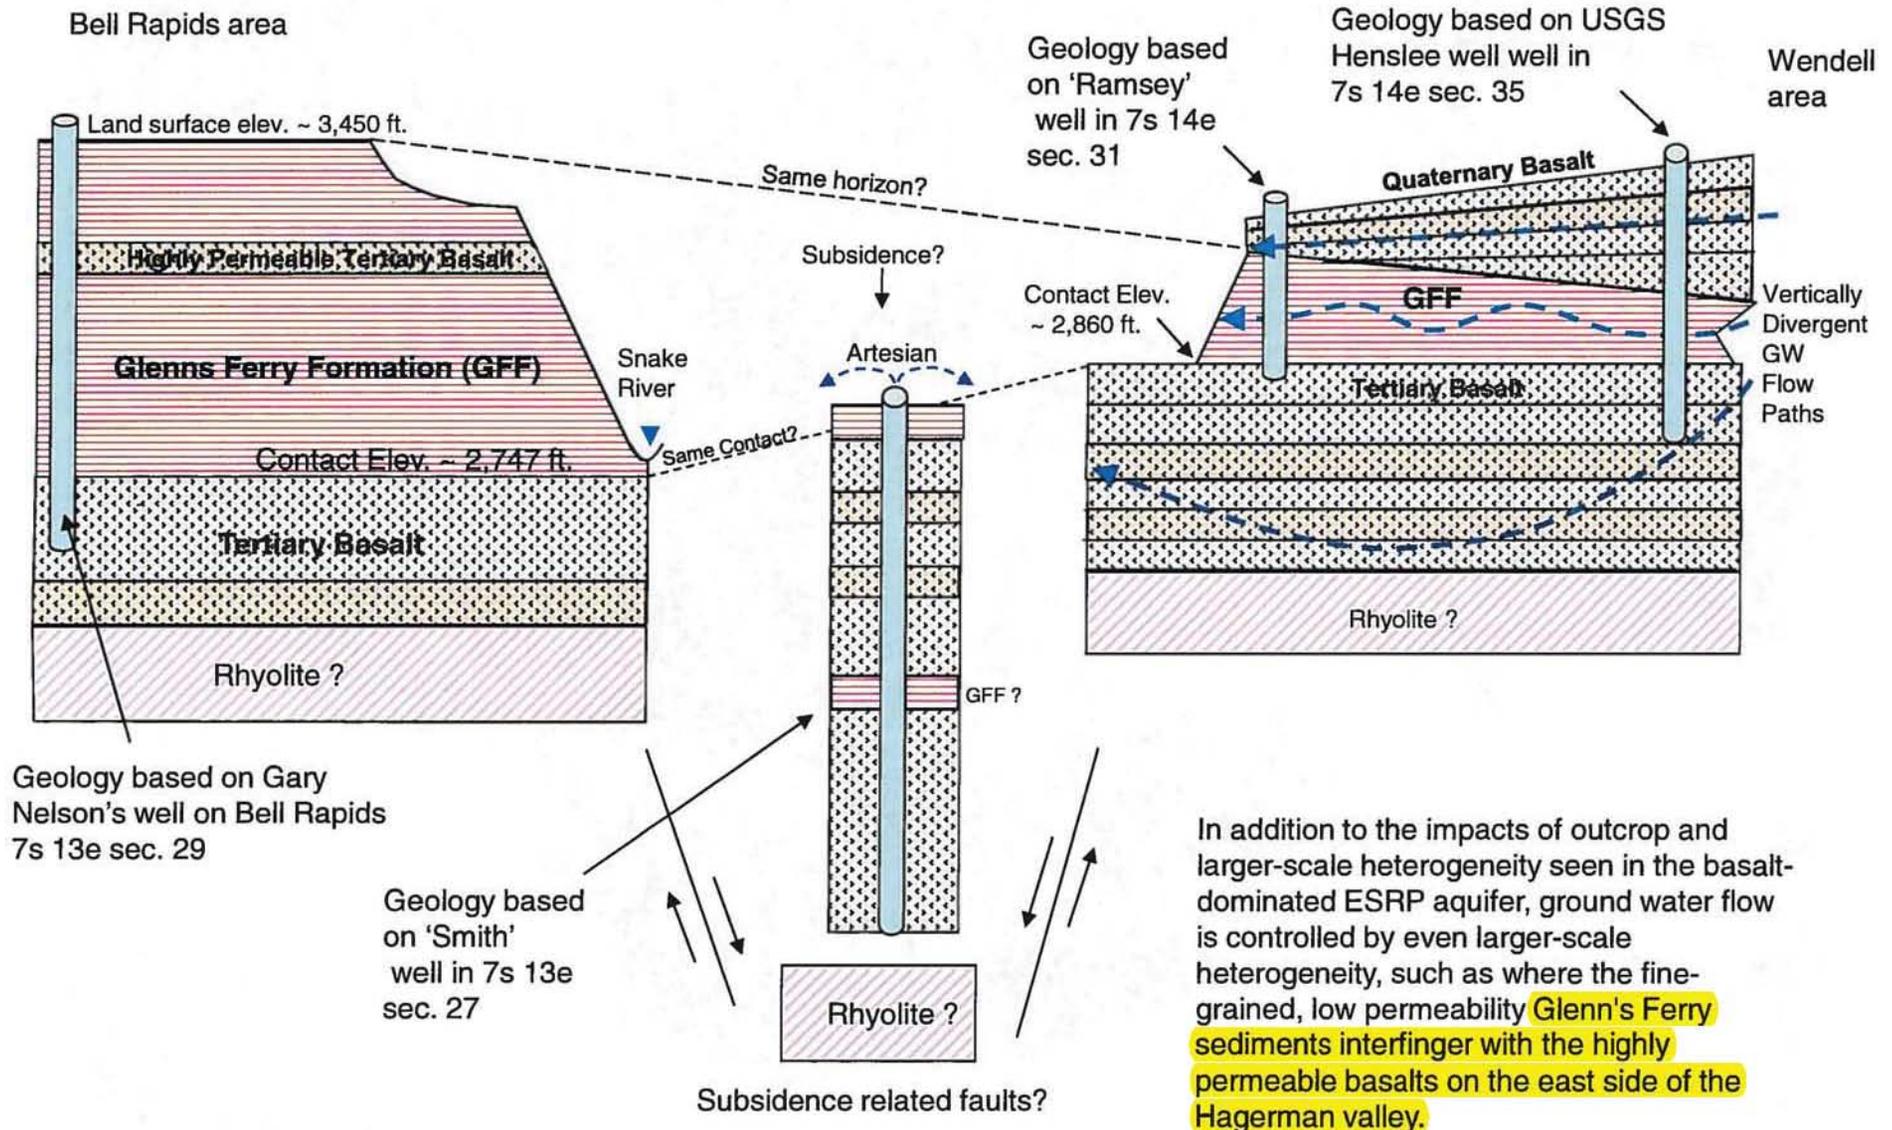
"East Meets West" – Geologic Transition Zone of the Eastern and Western Snake River Plain

(Conceptual Model)

Not to scale
