**PHASE II EVALUATION  
OF  
MANAGED RECHARGE  
ON THE ESRP  
DEVELOPMENT OF RECHARGE FACILITIES**

**David Blew**

**Idaho Department of Water Resources**

**April 2005**

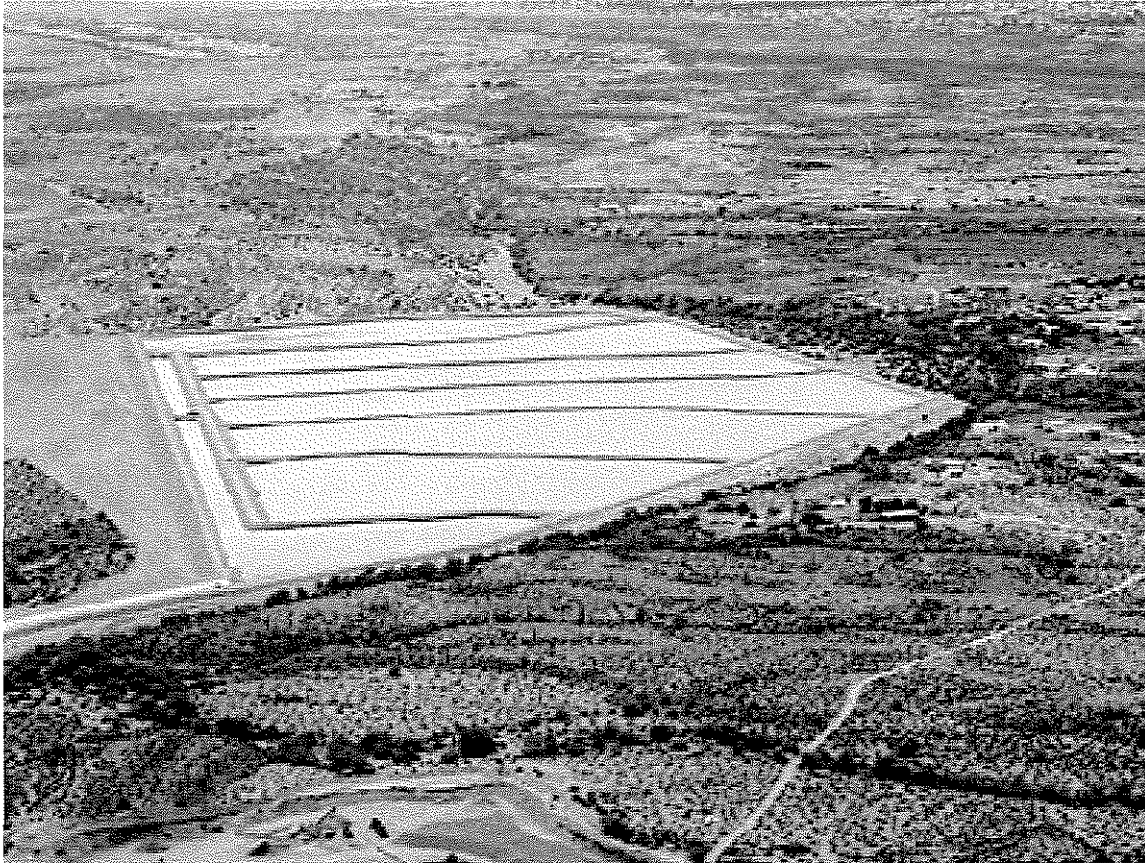
**Figure 1: Recharge operations at a constructed facility in Arizona.**

Construction of recharge facilities on the ESRP would require removal of over burden to expose bedrock at each site. These constructed facilities would then be back filled with appropriate size material to filter water and provide for a designed infiltration rate. This approach may also require the fracturing of bedrock formations to remove barriers for water entering into subsurface strata, or installation of injection wells. Injection wells, while expensive, may prove to be the best alternative for insuring recharge, particularly if subsurface geology is massive basalts that may mound water under the recharge facility. The layering of backfill into the site would not impede water infiltration but would provide for filtration of water at the surface. The design and construction of these facilities has the potential to decrease the required area for recharge basins (increase recharge/unit area) reducing potential environmental impacts and other related concerns.
